**AN EVALUATION OF THE CONVERGING CHEVRON PAVEMENT MARKING
PATTERN INSTALLATION ON INTERSTATE 94 AT THE MITCHELL
INTERCHANGE South-to-West RAMP IN MILWAUKEE COUNTY, WISCONSIN**

Alex Drakopoulos
Associate Professor
of Civil and Environmental Engineering
Marquette University

Milwaukee, Wisconsin
December 2001
Revised November 2003

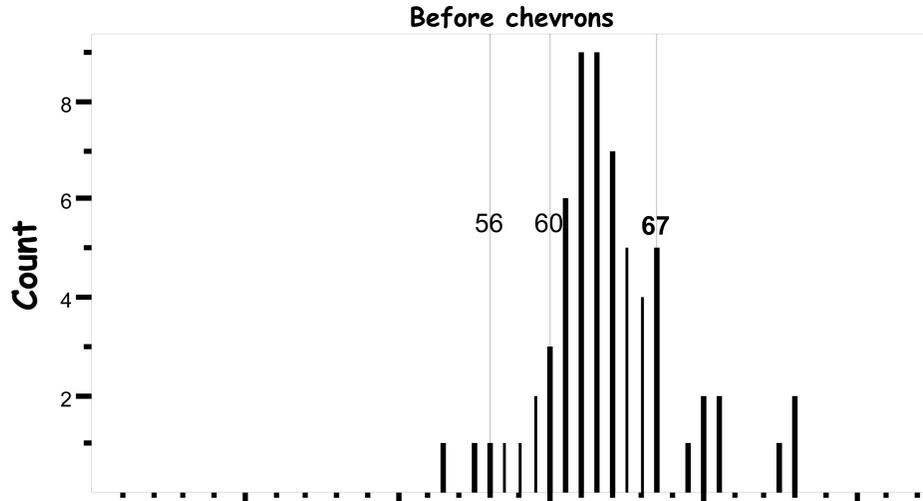
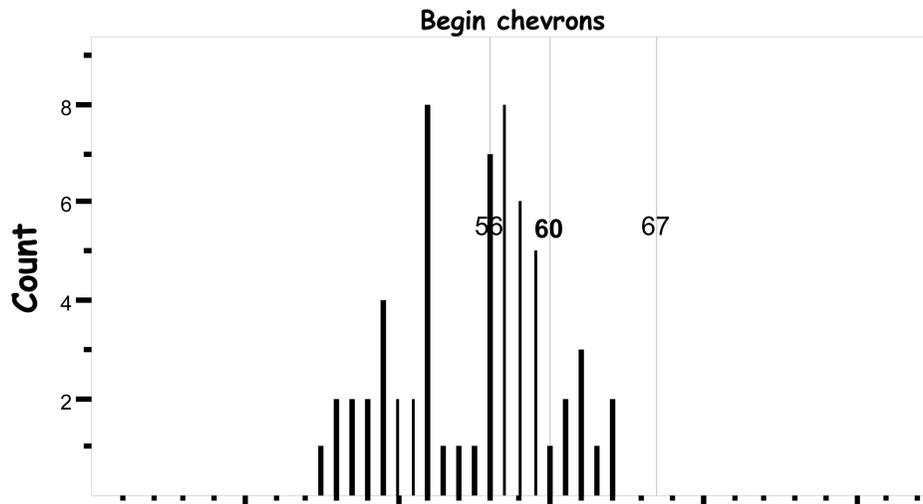
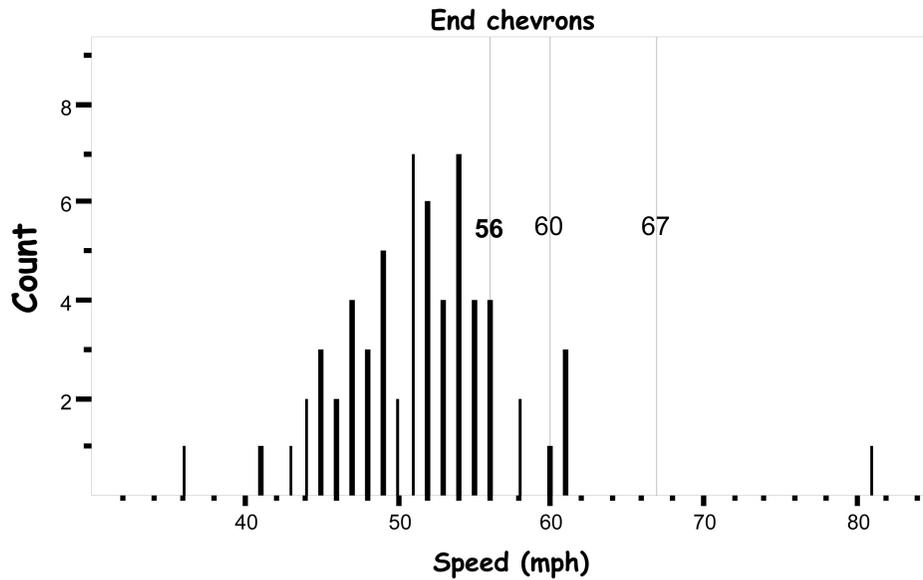
Figure 14. Speed Distributions at the three Data Collection Distances

N	Valid	63
	Missing	0
Mean		63.78
Median		63.00
Minimum		53
Maximum		76
Percentiles	85	67.00

N	Valid	61
	Missing	0
Mean		54.97
Median		56.00
Minimum		45
Maximum		64
Percentiles	85	59.70

N	Valid	63
	Missing	0
Mean		51.67
Median		52.00
Minimum		36
Maximum		81
Percentiles	85	56.00

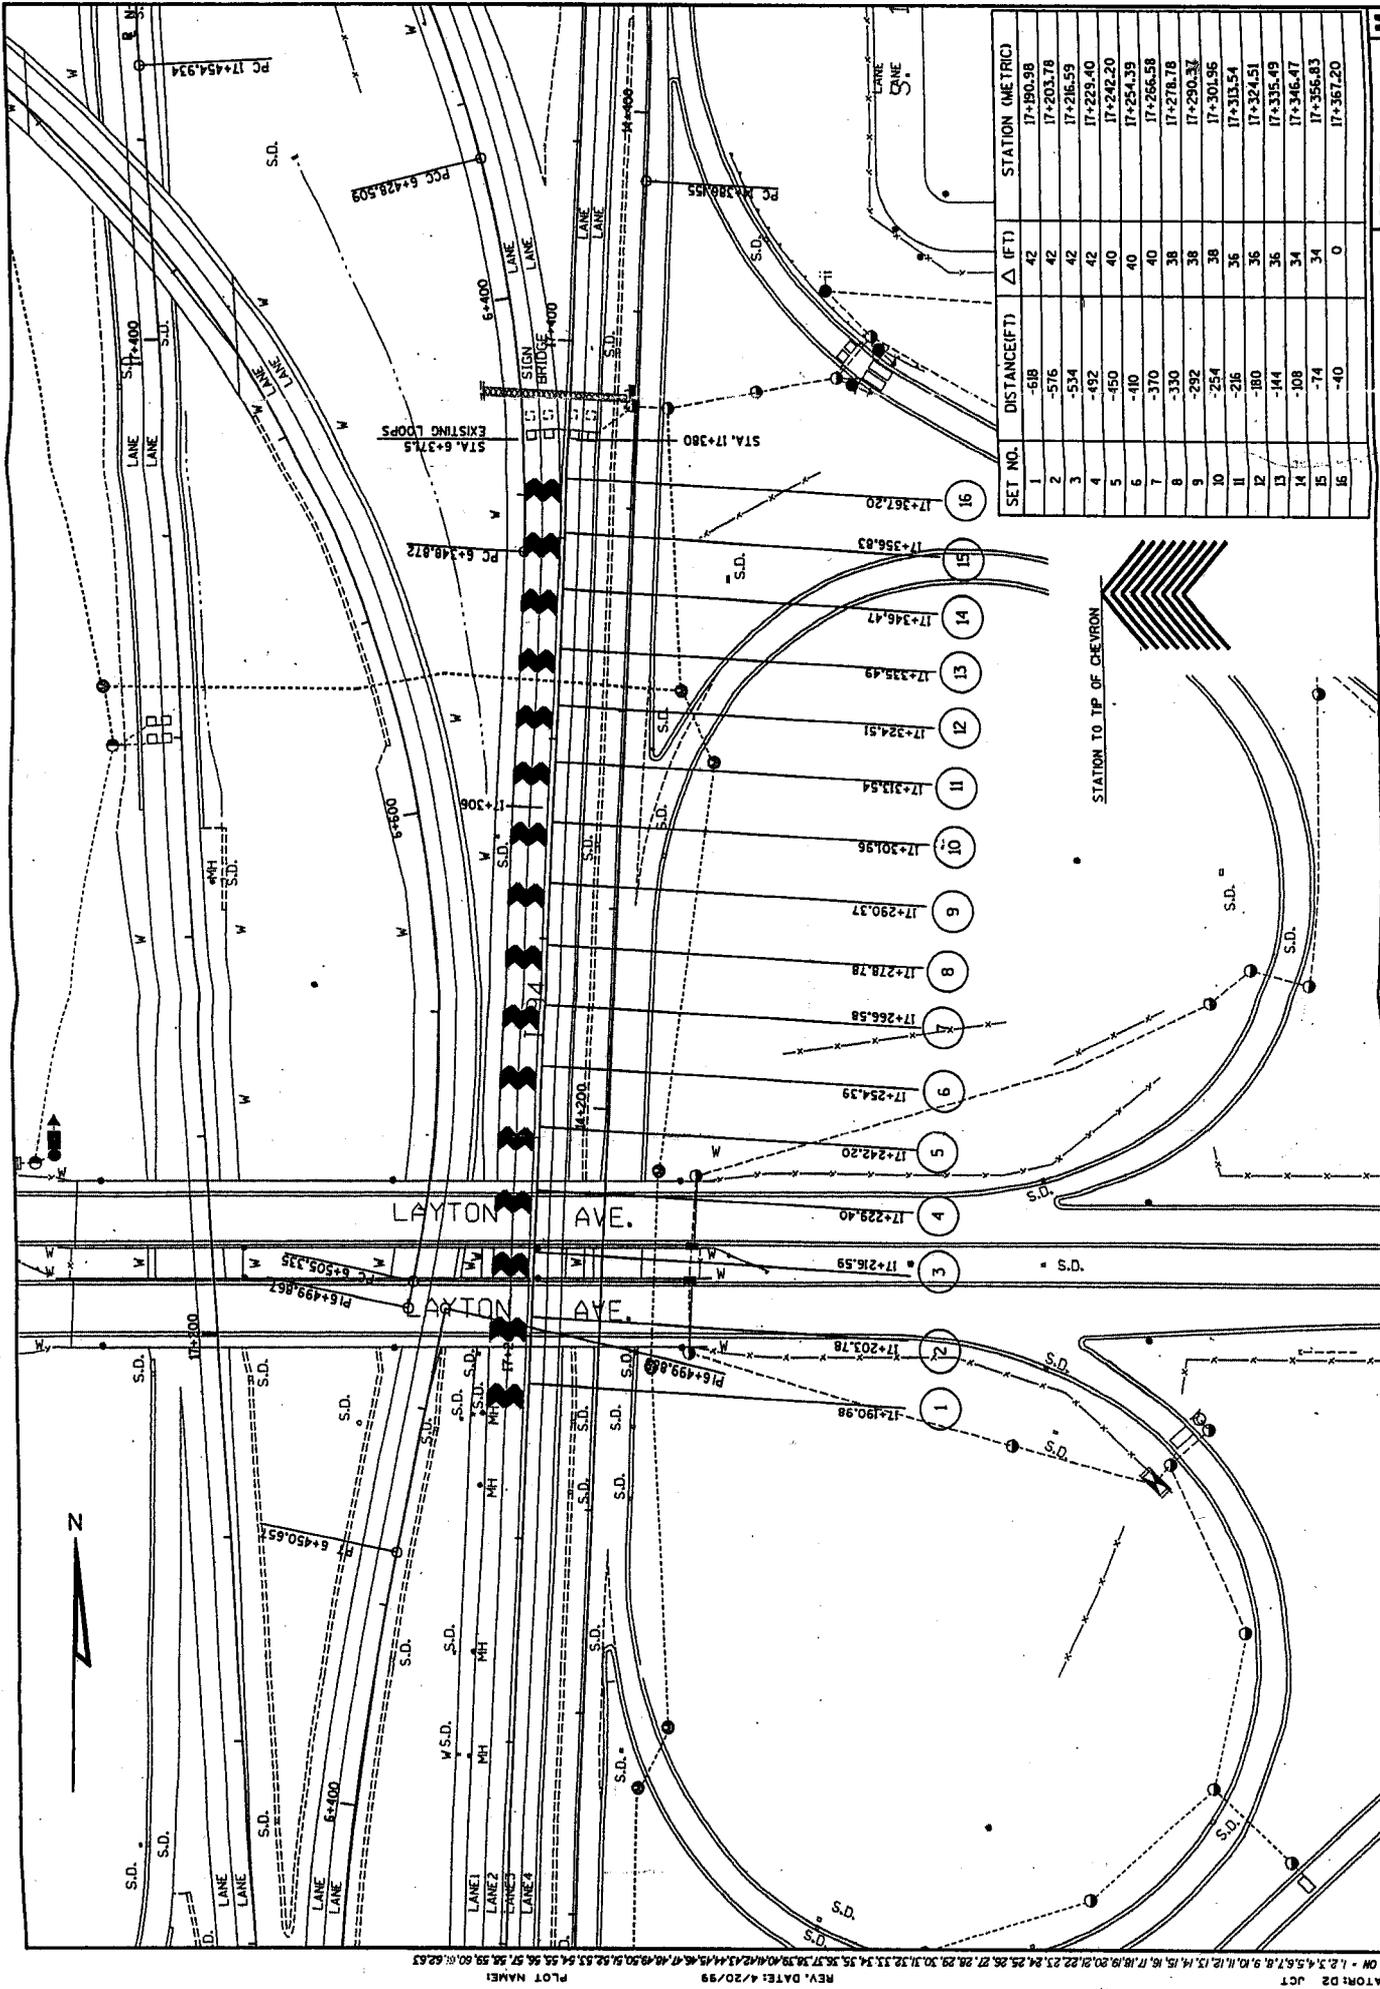
A3 Figure 1. Converging Chevron Pattern Layout.

ORIGINATOR: D2 JCT
 REV. DATE: 4/20/99
 PLOT NAME:
 FILE NAME: D2 40300241CHEVRONS.DWG
 SCALE: 1:1
 COUNTY: MILWAUKEE
 STATE PROJECT NO: 1030-10-70
 SHEET NO: M

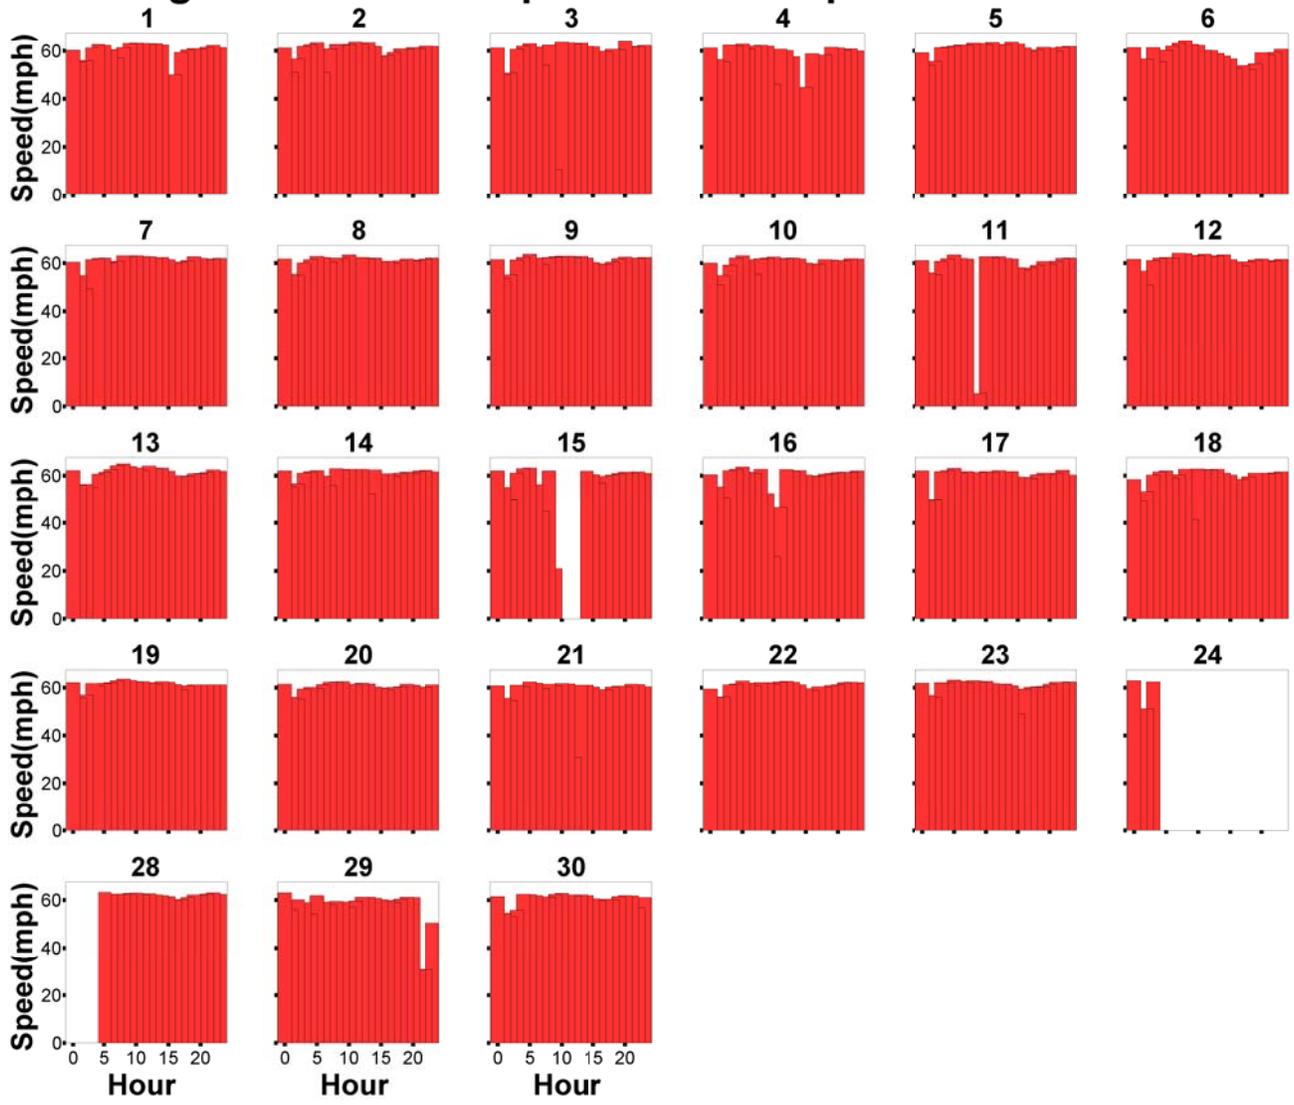
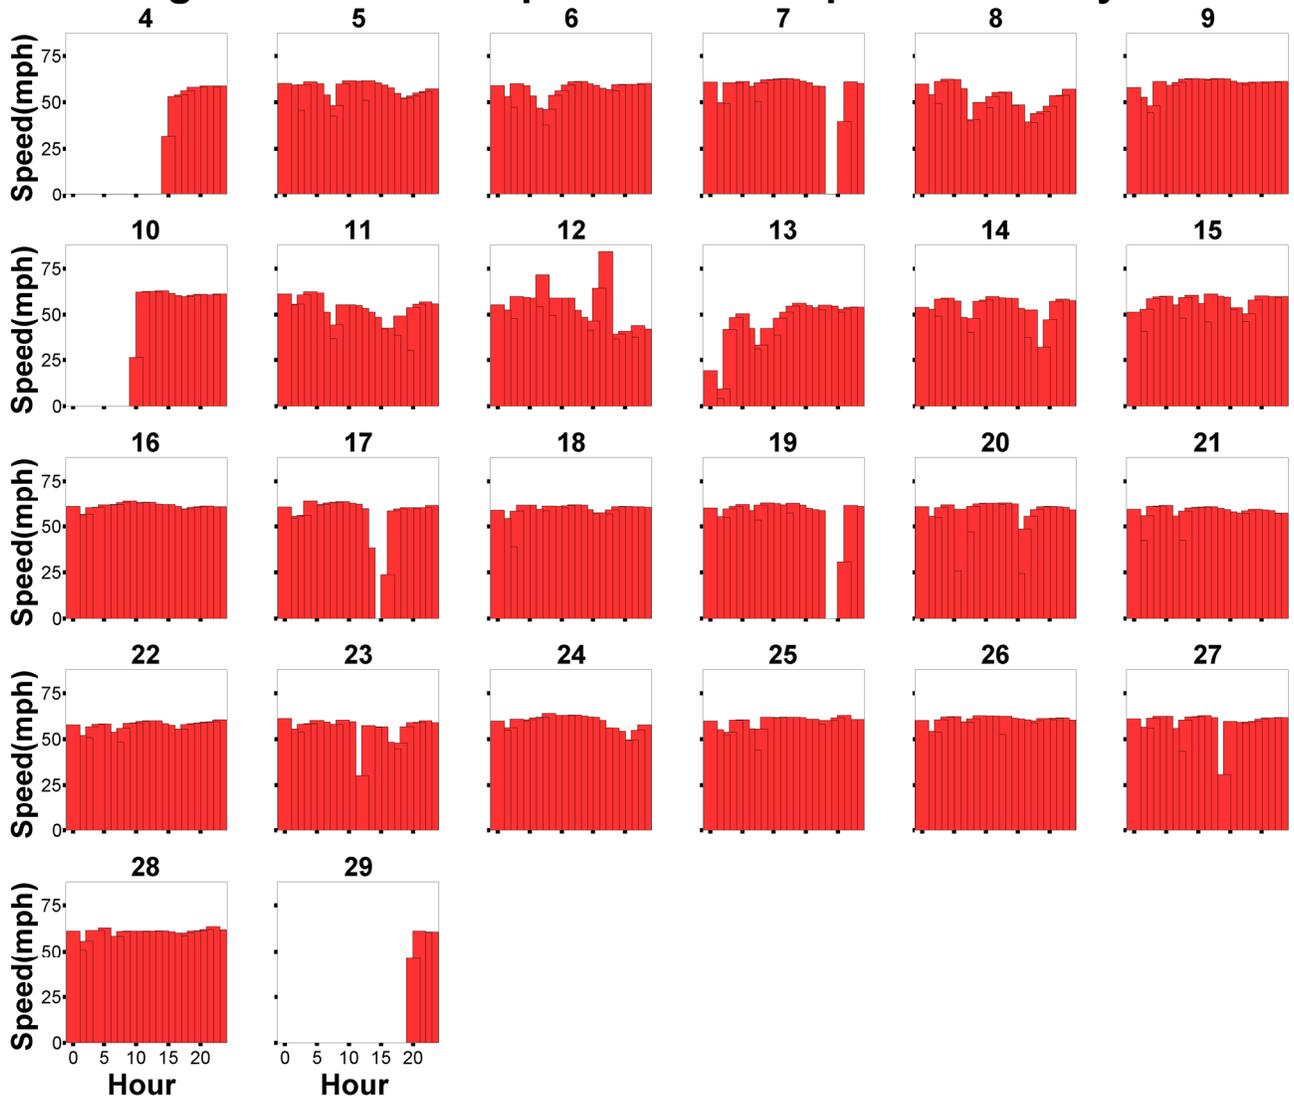
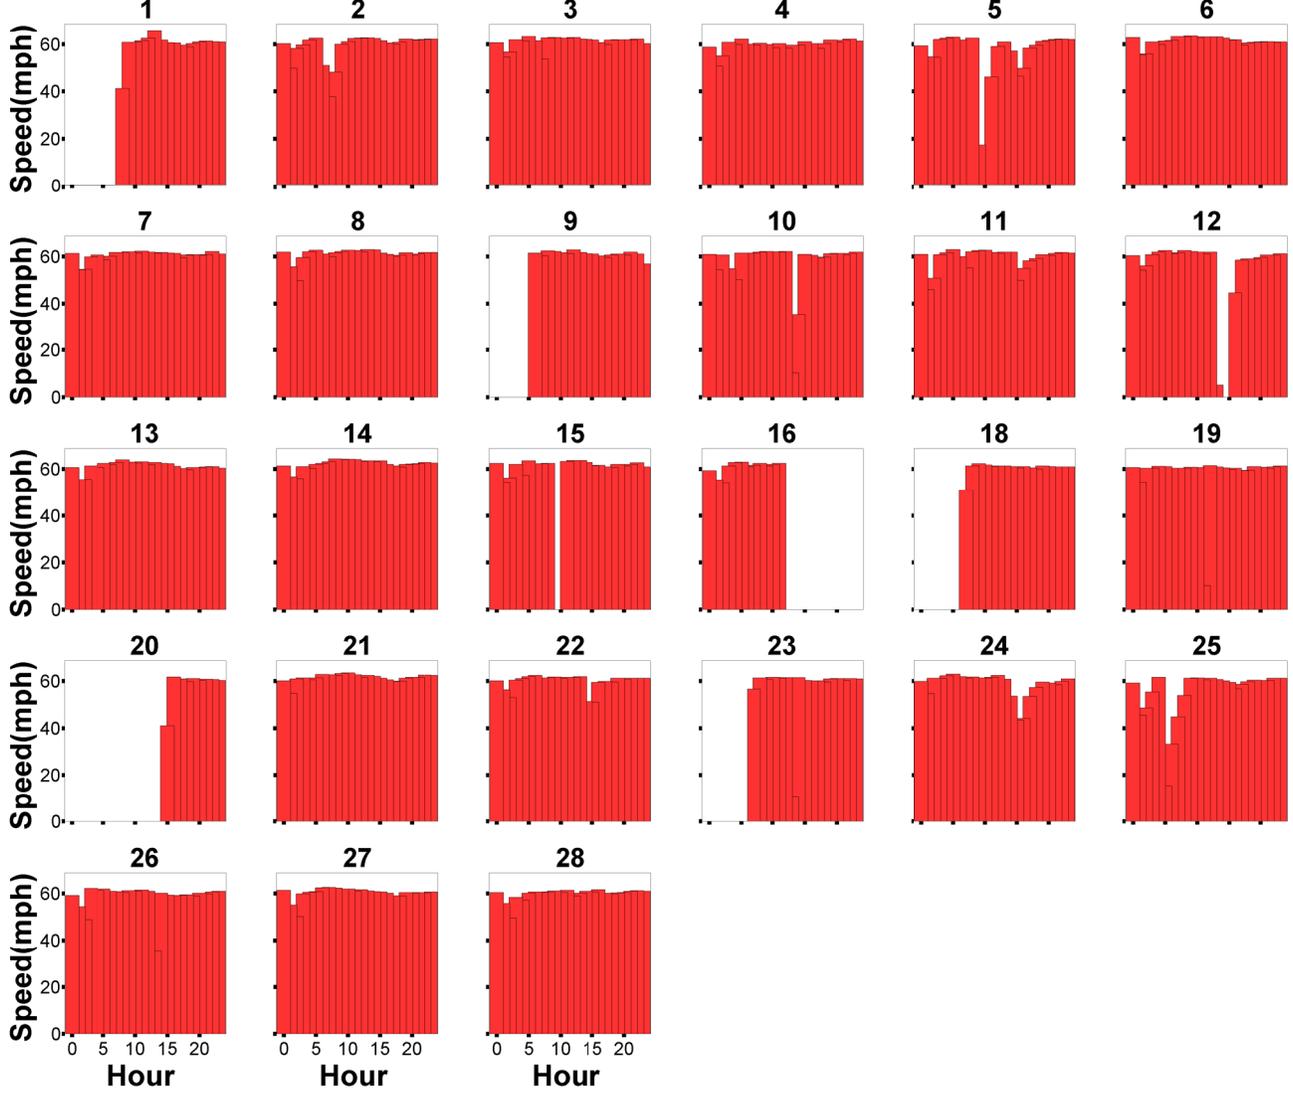
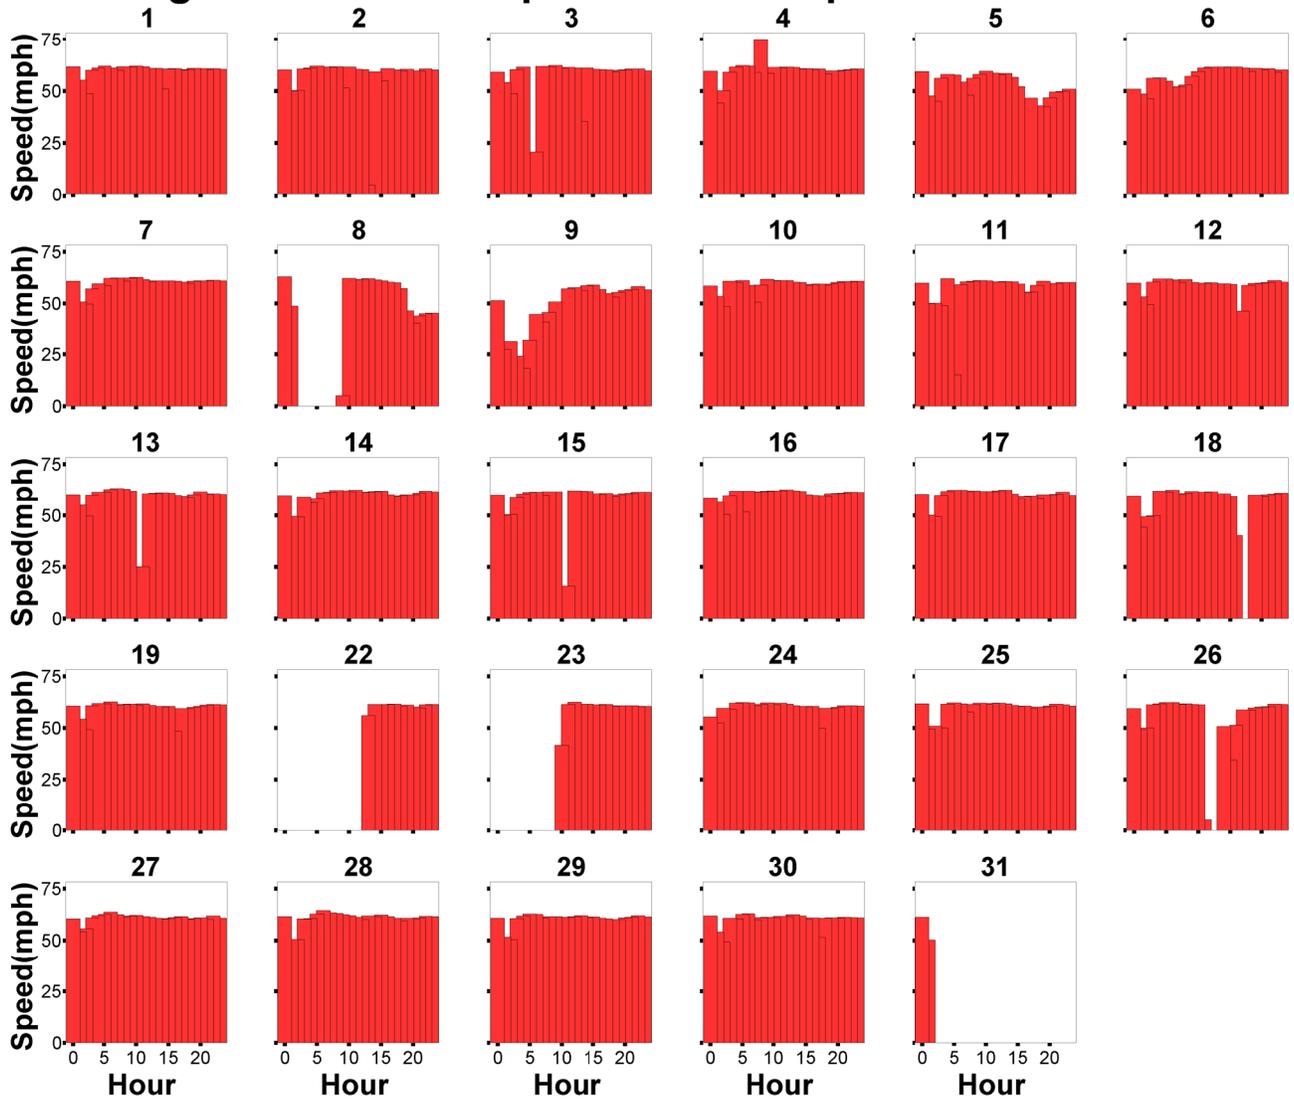
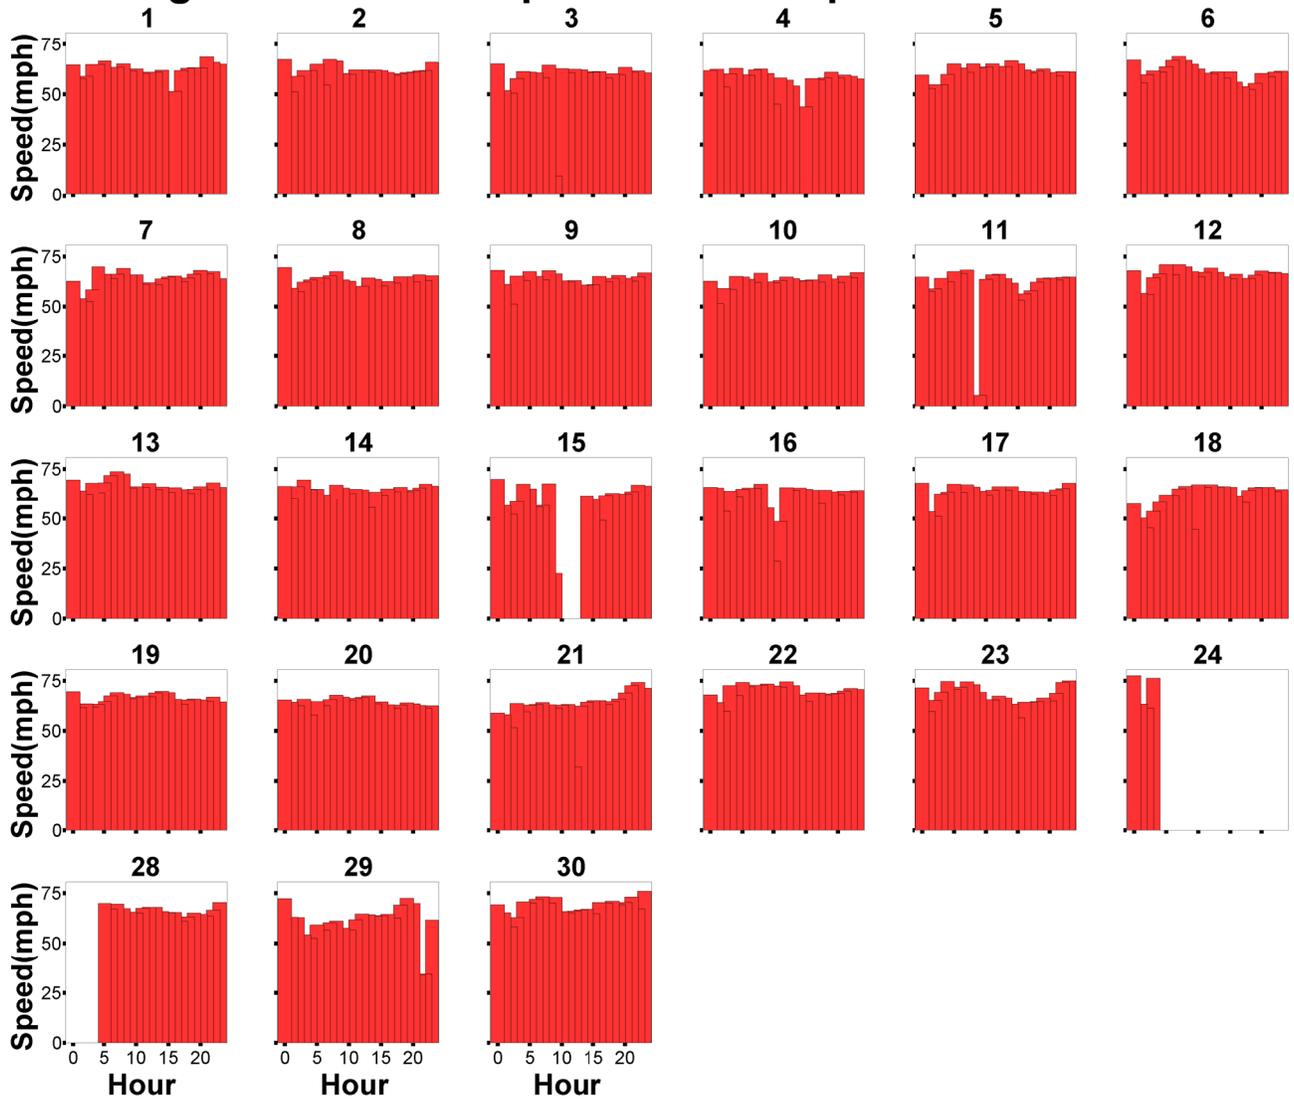
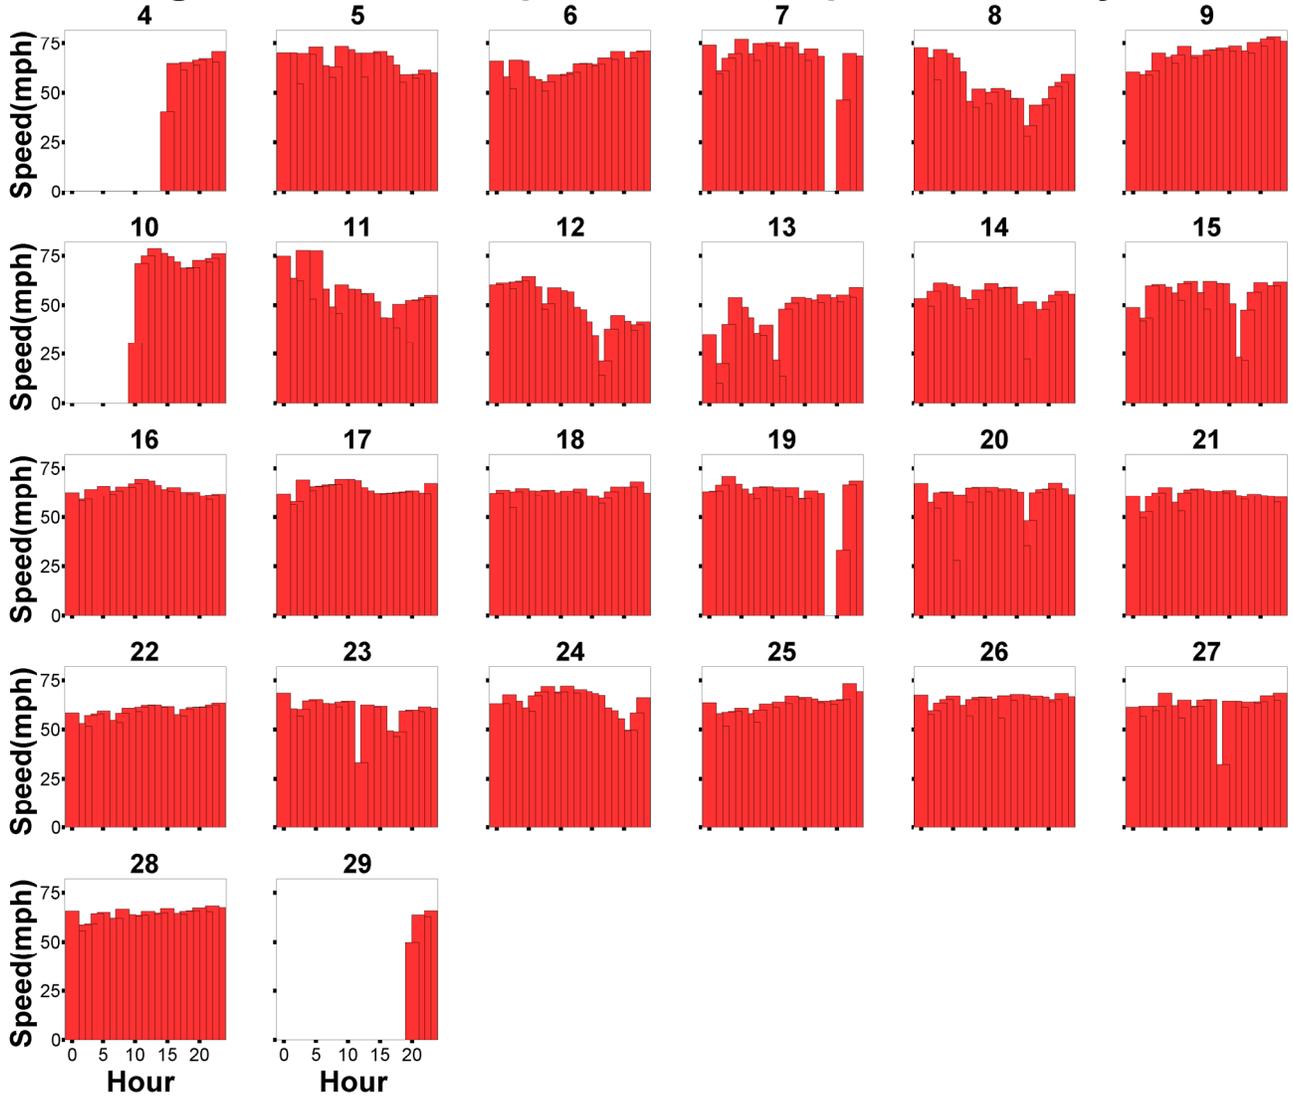
APPENDIX 4
Detector Speeds Before Period

Appendices 4 and 5 present mean hourly speed graphs for each day of the before and the after period, respectively. The graphs were used to identify missing information and times during which detectors malfunctioned.
