**AN EVALUATION OF THE CONVERGING CHEVRON PAVEMENT MARKING
PATTERN INSTALLATION ON INTERSTATE 94 AT THE MITCHELL
INTERCHANGE South-to-West RAMP IN MILWAUKEE COUNTY, WISCONSIN**

Alex Drakopoulos
Associate Professor
of Civil and Environmental Engineering
Marquette University

Milwaukee, Wisconsin
December 2001
Revised November 2003

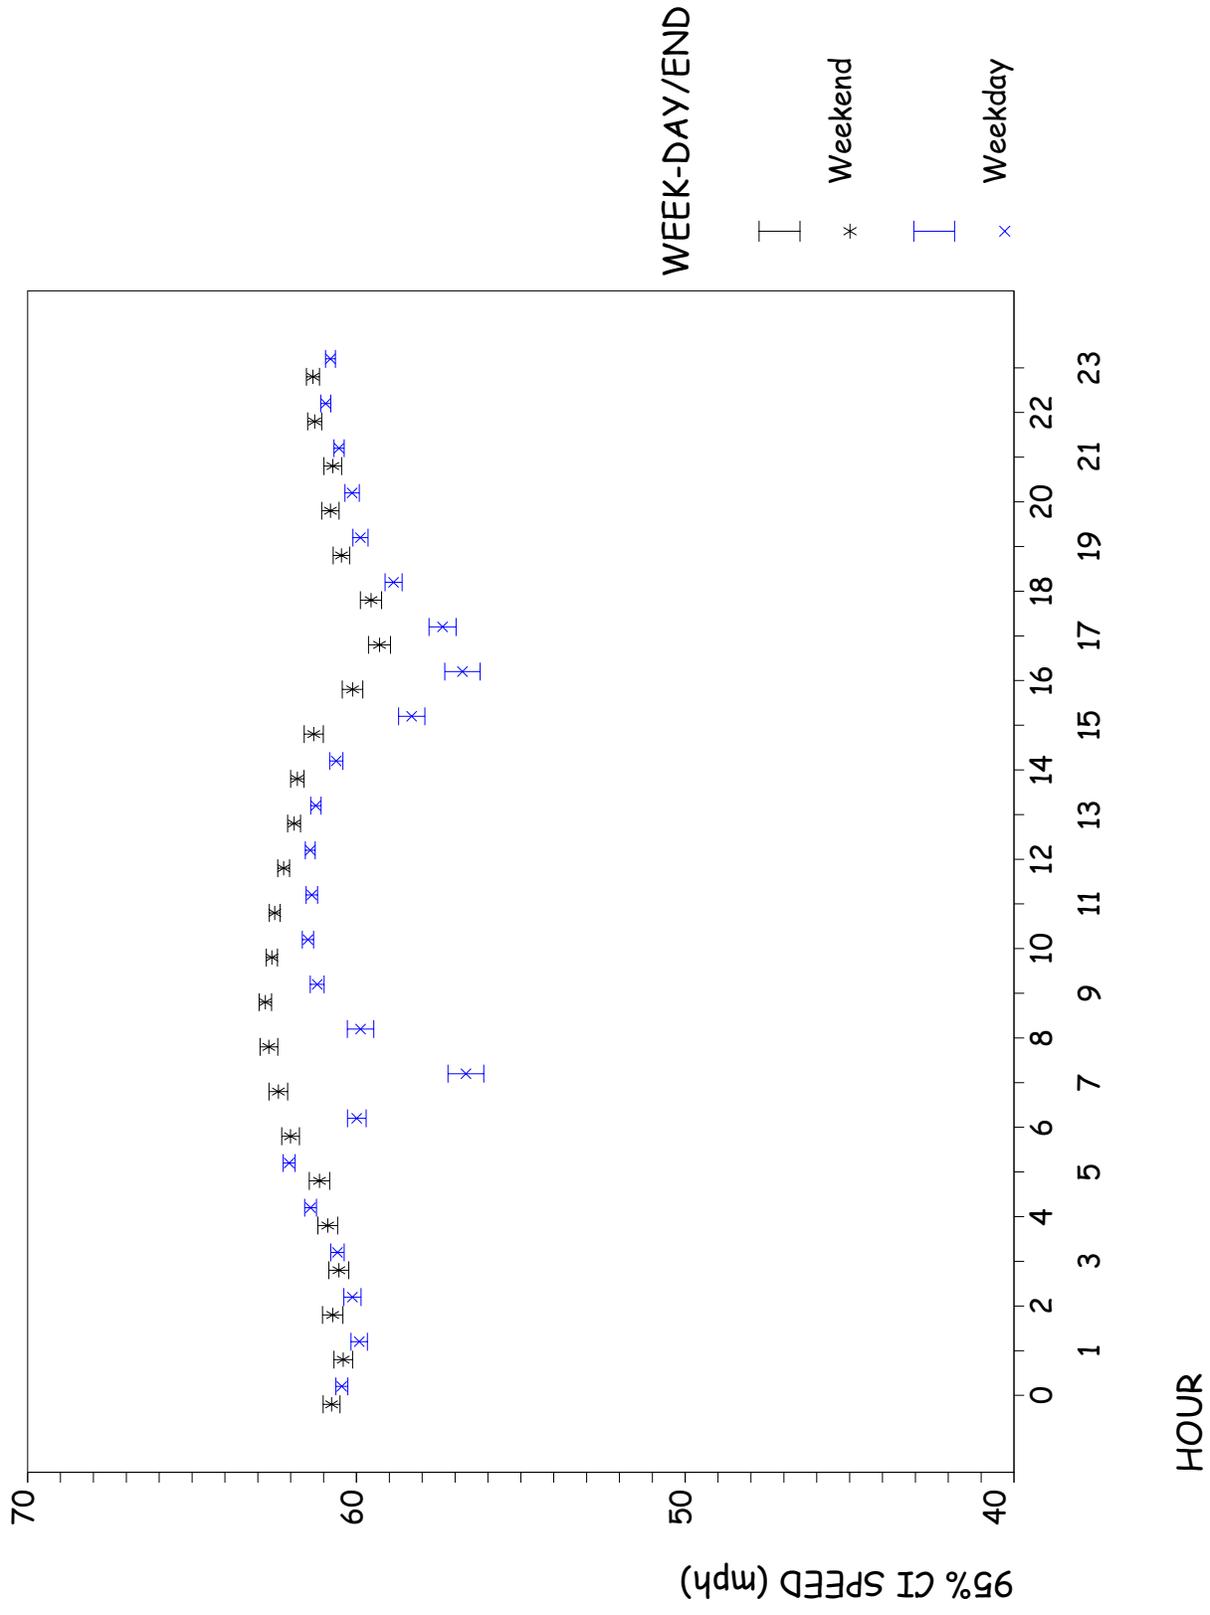
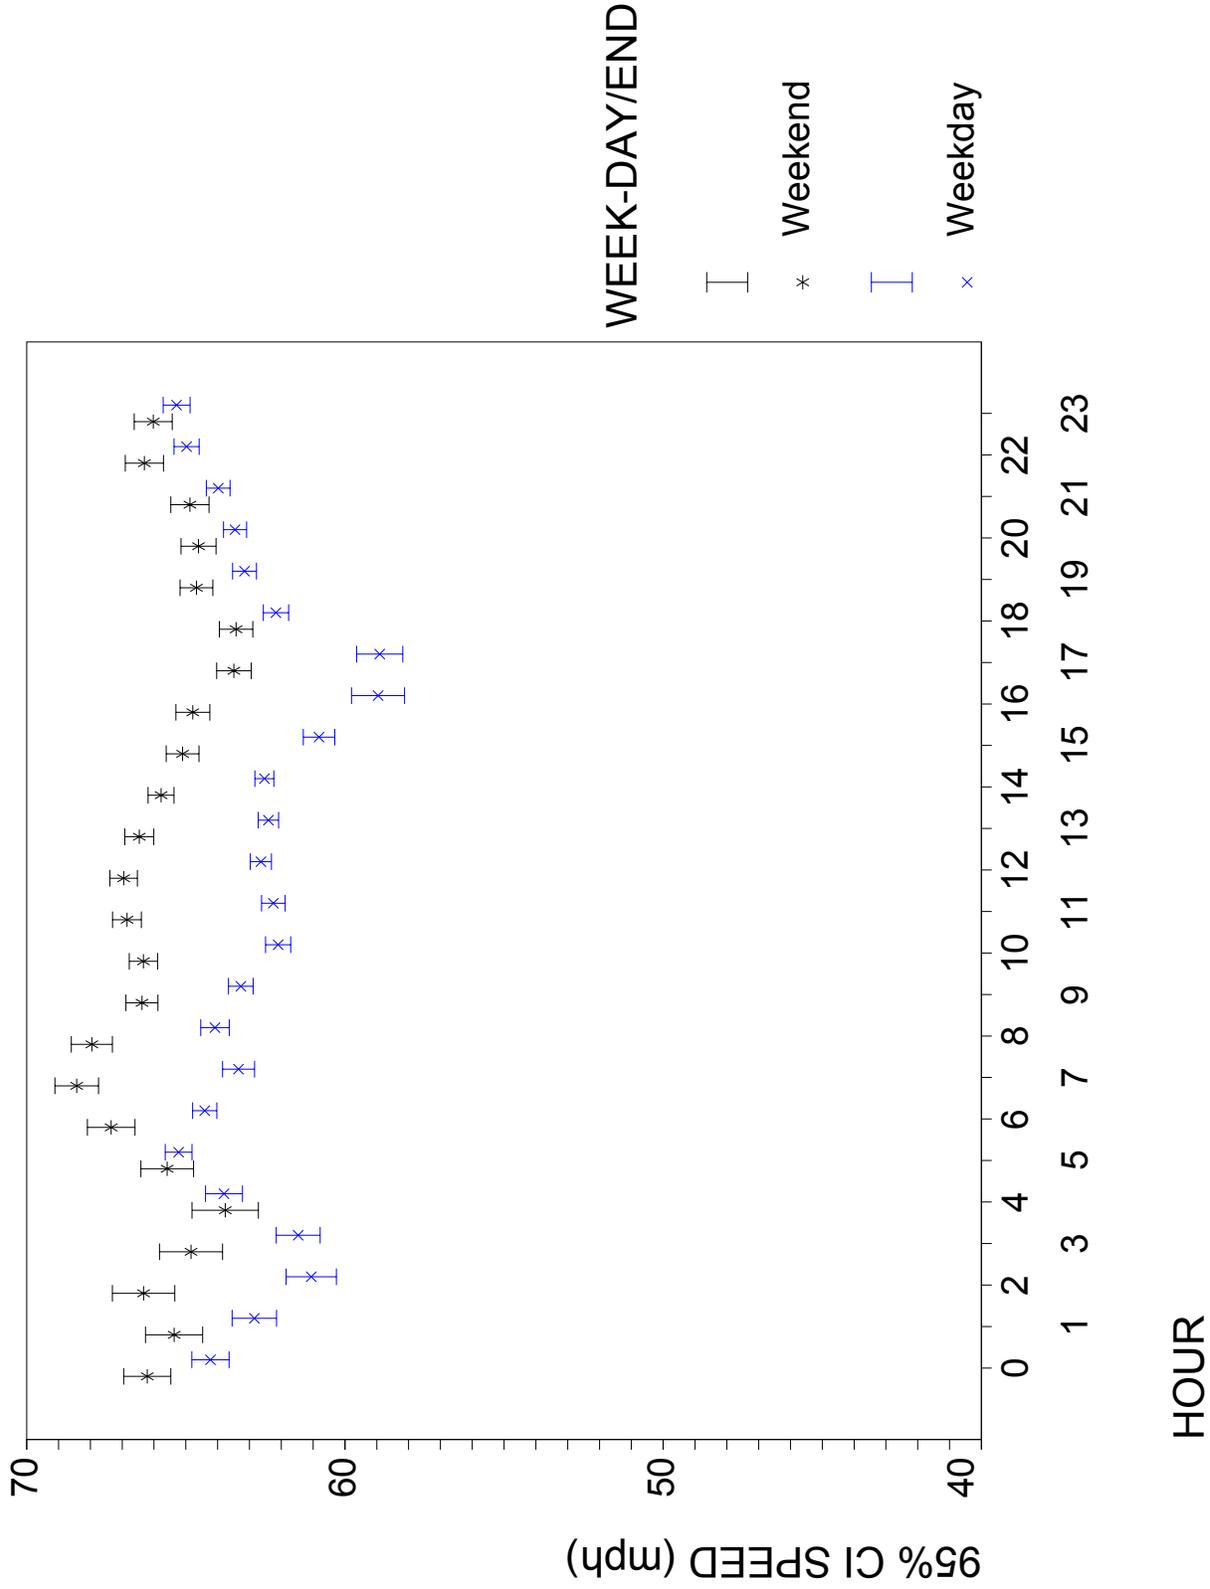
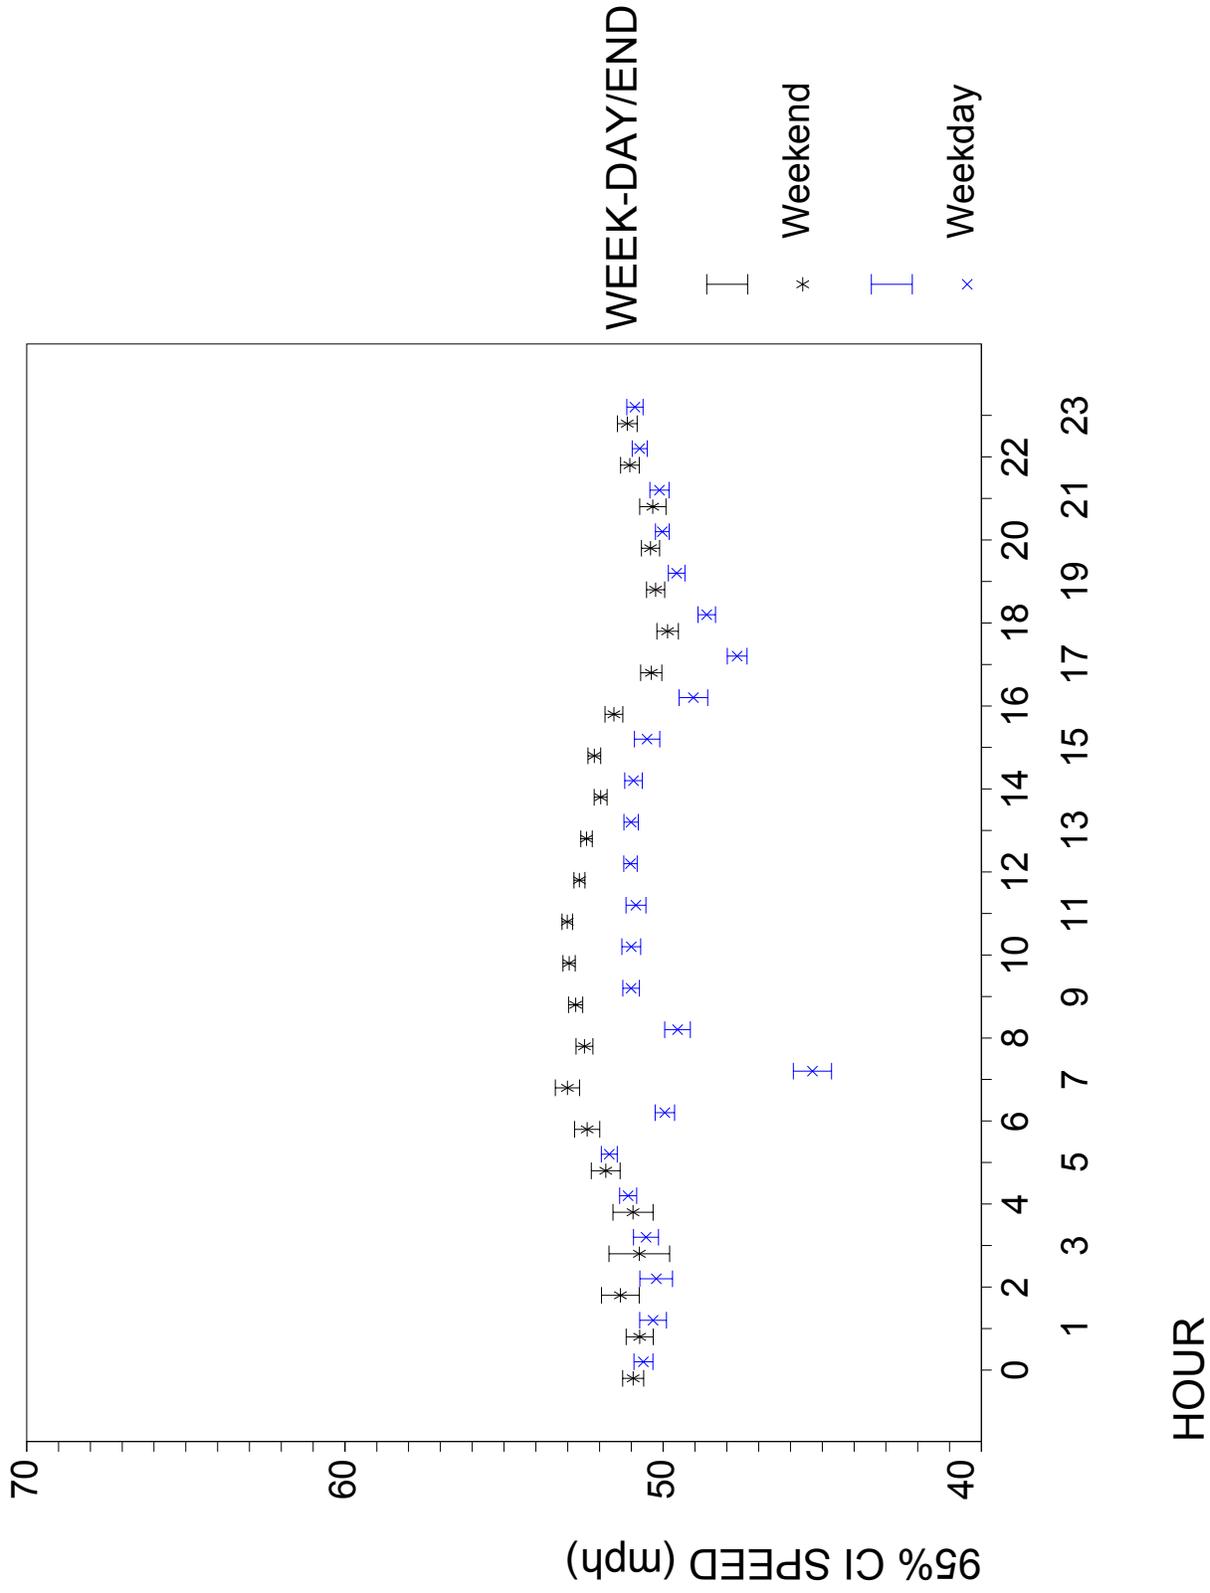
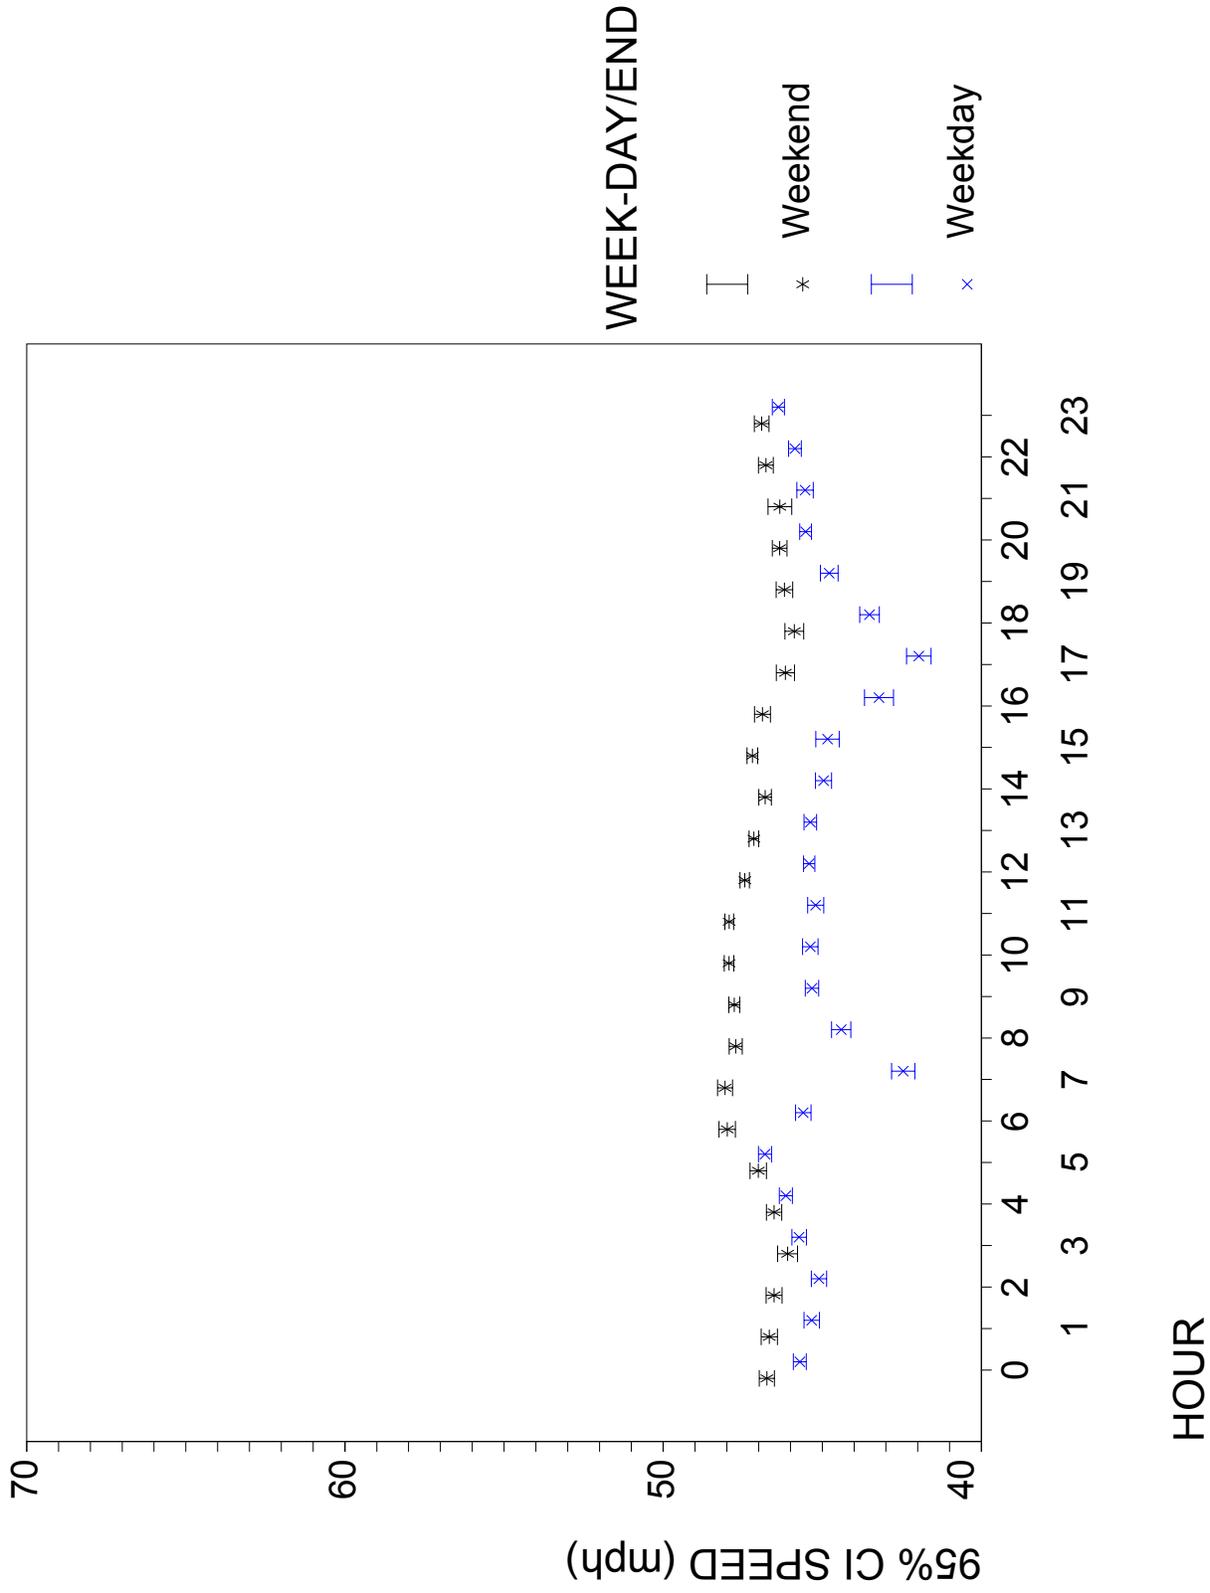
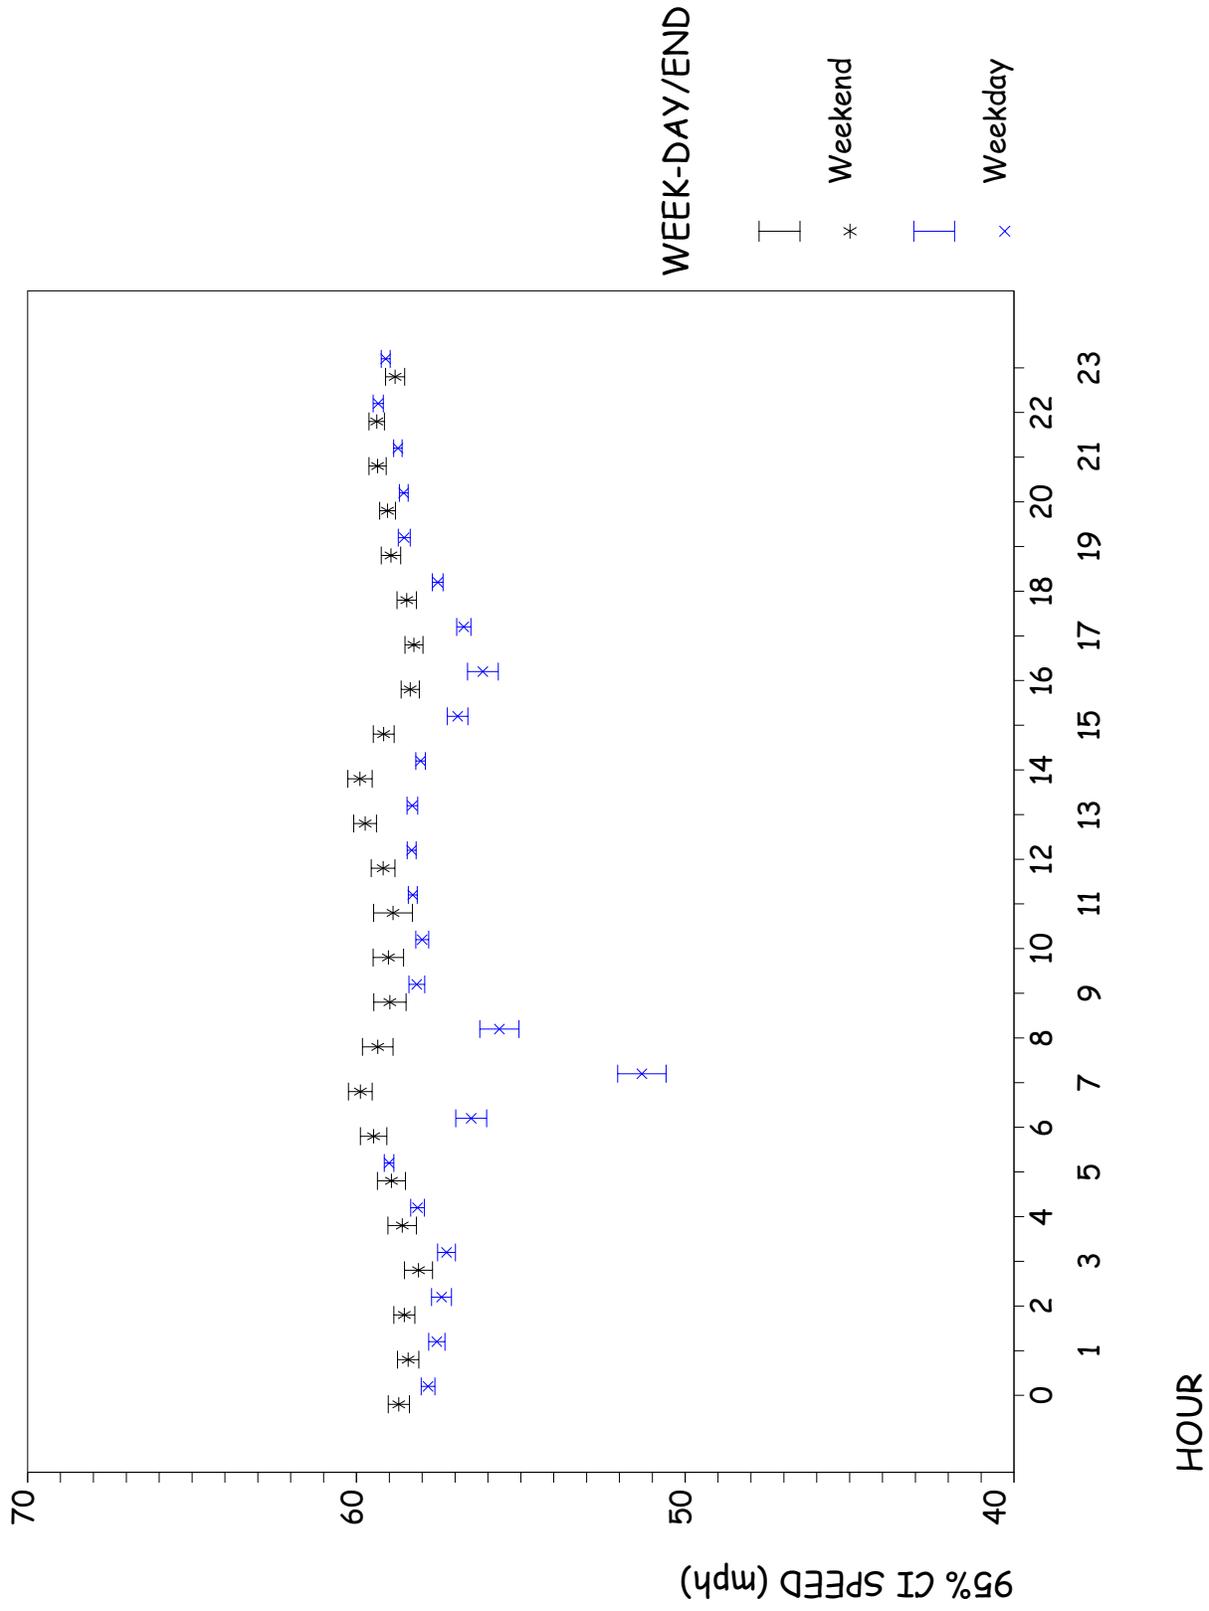
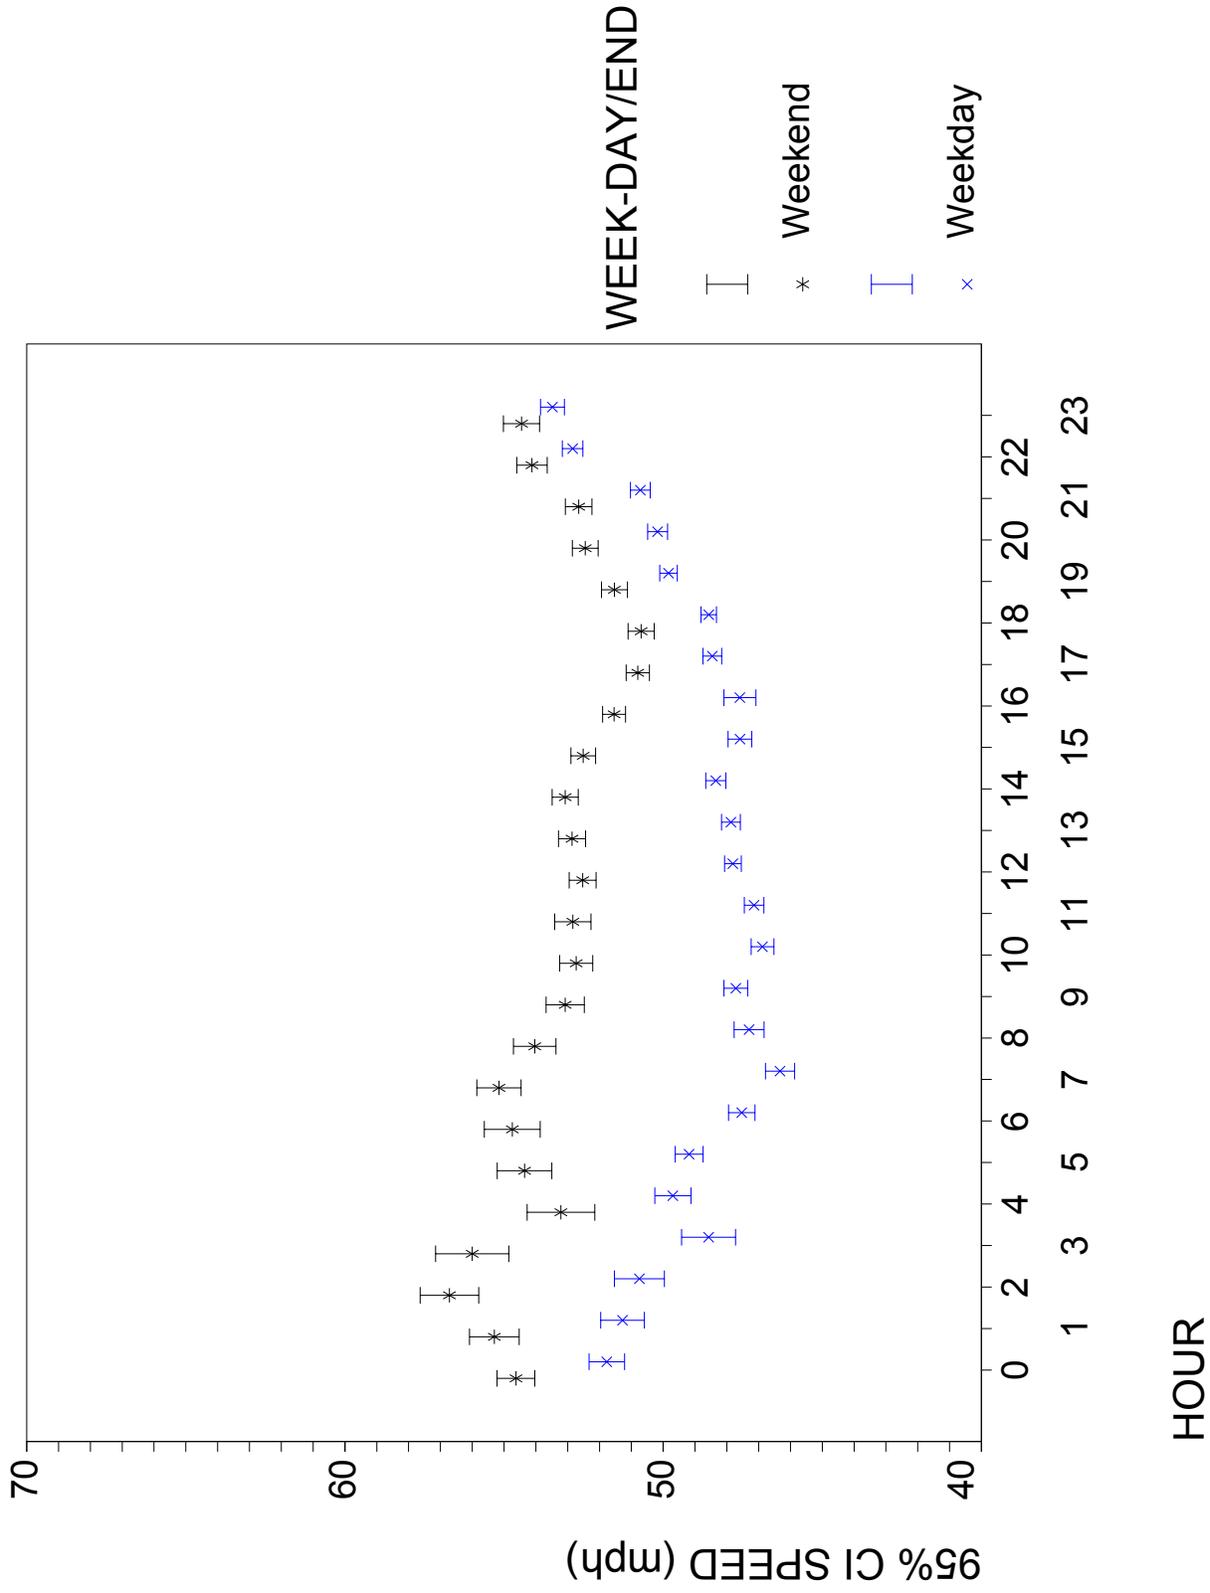
Detector 95% Confidence Intervals for Average
Hourly Speeds-Before and After Periods.

Summary: A dramatic change in speeds was observed for detector **B**, where average speeds dropped by 15 mph, and 85th percentile speeds dropped by 17 mph during the after period. Detectors **A** and **C** also experienced average speed reductions, but of much smaller magnitude: 3 and 1 mph respectively. Detector **D** had an average speed increase of 2 mph. Average and 85th percentile weekend speeds were universally higher than weekday speeds. Speed changes between the ‘before’ and the ‘after’ period were such that speeds at all hours of the day shifted in the same direction and by the same amount (parallel translation upward for detector **D**, downward for detectors **A**, **B** and **C**) as evidenced in **Appendices 8, and 11**.
