Smart Work Zone Deployment Initiative Summer 2001 Travel Time Prediction System (TIPS)

Wisconsin Evaluation

Smart Work Zone Deployment Initiative Wisconsin Evaluations Summer 2001 Travel Time Prediction System (TIPS)

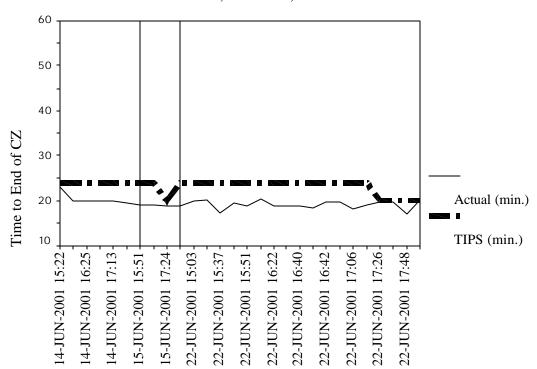
Figure 1. Actual and TIPS Travel Times

Figure 1 presents Actual (continuous line) and TIPS travel time data (broken line) for June 14, 15, and 22 for CMS #1. It should be noted that the data represent measurements at discrete time instances–lines are provided for easier visualization. Time intervals between observations are not of equal duration-they represent intervals between the times that teams passed a TIPS sign. Vertical lines are placed within the Graph to separate data collection days. Each line corresponds to the first observation of the day. Complete series of similar Graphs for CMS #1 and CMS #3 are presented in Figures B1 and B2 pp. B-1 through B-8 in Appendix B.

Actual travel time data patterns, travel times were consistently overpredicted. Underpredictions occurred in some instances of higher Actual travel times, for example, on July 1 and July 29 (CMS displays malfunctioned on the latter date, but electronic data were available). There are some instances under non-congested conditions, when TIPS overpredicted (for example, June 14, 15, 22, August 9 and 10), but differences between Actual and TIPS travel times are very close to the four-minute permissible range.

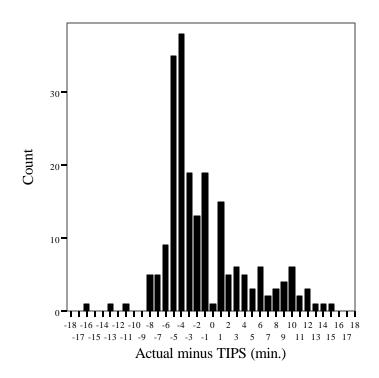
Figure 3. Actual Minus TIPS Travel Time CMS #3

Figures 2 and 3 present histograms of Actual minus TIPS travel times, in minutes, for CMS #1 and #3, respectively. The same information is presented in tabular form in Tables B1 and B2 in Appendix B pp. B-9 and B-10. Time intervals in Figures 2 and 3 and Tables B1 and B2 are defined in the following manner: differences greater than three and less than, or equal to four

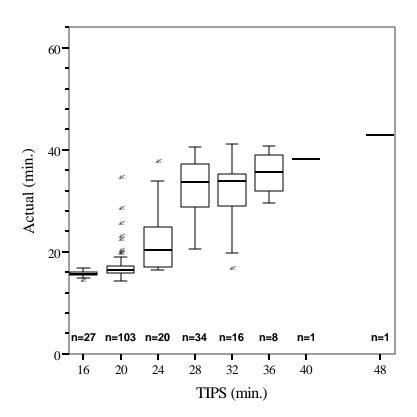
Figure 4. Boxplot TIPS and Actual Travel Times CMS #3

of the Actual travel time data. The whiskers define the minimum and the maximum Actual travel time values. Any values that are between 1.5 and 3.0 box lengths from the upper or lower edge of the box are defined as "outliers" and are represented by empty circles. Values in excess of 3.0 box lengths from the same box edges are defined as "extreme" values, and are represented by asterisks. In summary, box plots provide five distribution points: minimum value, the 25th, 50th and 75th percentile values, and the maximum value. In addition, information is provided on outlier and extreme values. This information can be used to judge whether the distribution is symmetric (median in the middle of the box, whiskers of equal lengths for a symmetric distribution) and whether the distribution is spread-out or centered around the median.

Figure 4 indicates that Actual travel times were within the required four-minute interval when TIPS indicated a travel time of 16 minutes. The same was true when TIPS indicated a travel time of 20 minutes, for most observations. However, the median value was approximately 17 minutes in that case, and most Actual travel times were below 20 minutes, the TIPS travel time. Three (out of 103) Actual travel times exceed the upper limit of 24 minutes. (They are shown as extreme values, because the "box" containing 50% of the observations around the mean has a very narrow range. What is important for this category is not that these three are shown as "extreme" values, but, rather, that the majority of Actual times is consistently below the TIPS time.) It is helpful to consult Table B4 here. It shows a heavy concentration of Actual times four and five minutes below TIPS times.

For TIPS indications of 24 minutes, approximately 50% of Actual travel times were below the lower limit of 20 minutes (24 - 4 minutes) and some observations were above the upper limit of 28 (24 + 4) minutes. For TIPS indications of 28 minutes, more than 50% of Actual travel times were above the upper limit of 32 minutes, and some observations were below the lower limit of 24 minutes.

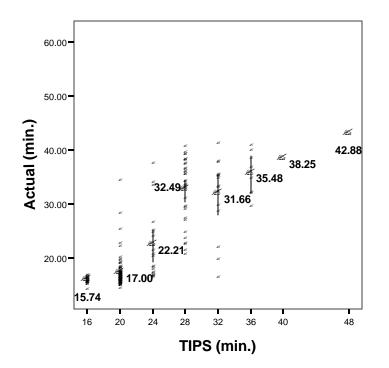
Figure 5. Scatter Plot of Actual Versus TIPS Travel Times for CMS #3

Figure 5 is a scatter plot of Actual travel times in relation to TIPS travel times for CMS #3. (Note that the number of cases within each TIPS travel time category can be read off of Figure 4). Average Actual travel times were provided for each value of TIPS travel time. Most average Actual travel times were very close to the respective TIPS travel times: 0.3 minutes for TIPS time of 16 minutes, 3.0, 1.8, 4.5, 0.3 and 0.5 minutes for TIPS times of 20, 24, 28, 32 and 36 minutes, respectively. However, the scatter of Actual travel times is quite broad within each TIPS travel time category. (Darker areas of the scatter plot indicate higher concentrations of observations and correspond to the box-and-whiskers information in Figure 4). Information for both evaluated CMS is presented in Appendix B, in Figures B5 and B6. Data for CMS #1 were very similar: the differences ranged between 0.3 to 4.5 minutes as well and there was a rather wide scatter of observations around the means.

A linear regression model was postulated, using TIPS predictions for CMS #3 to estimate Actual travel time. The model is presented graphically in Figure B8, page B18; supporting statistics are presented at the bottom of the same page. The R-square value was 0.681. Both the coefficient of the independent variable (TIPS time) and the constant are statistically significantly different from zero at the 0.05 level of significance. Similar findings apply to the model calibrated for CMS #1. The calibrated regression model for CMS #3 is shown in Equation (1) below.

Actual Travel Time =
$$-5.920 + 1.213$$
 (TIPS time) Equation (1)

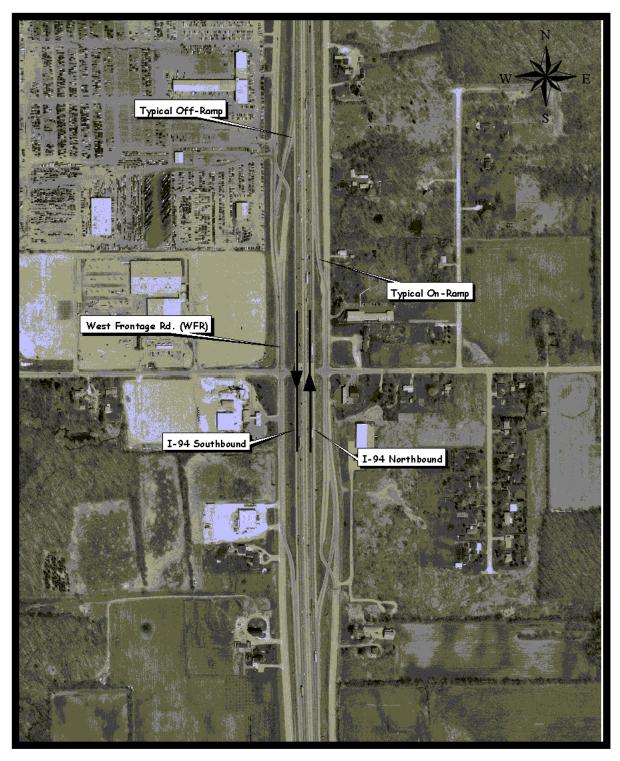
Figure A3. I-94 Corridor Construction Zone, Taper Detail

The construction zone extended from approximately 2,000 feet south of Oakwood Road in Milwaukee County (Figure A1), to the south end of Racine County at County Trunk Highway KR, located at the Racine County border, with a total length of approximately 12.5 miles. Construction was scheduled in two phases: the left half of the moving lanes (median lane and half of the middle lane) was replaced in both directions of travel during construction phase one, and the right half of the moving lanes (half of the middle lane) was replaced during construction phase two.

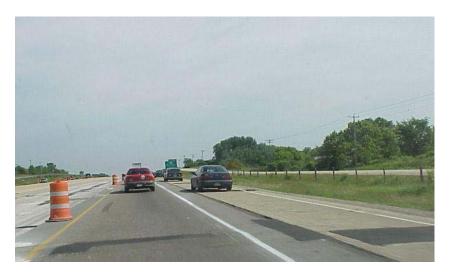
Picture C2. I-94 Southbound Racine County. Construction Phase One: Left Half of Travel Lanes Removed, Right Shoulder Rumble Strips Patched Over with Asphalt

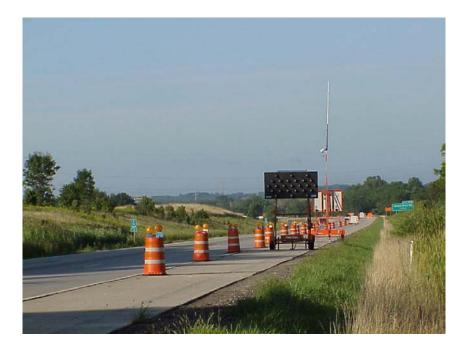
Picture C3. I-94 Southbound Racine County. Construction Phase Two. Construction Zone Taper Detail: TIPS Detector Visible Behind Arrow Board.

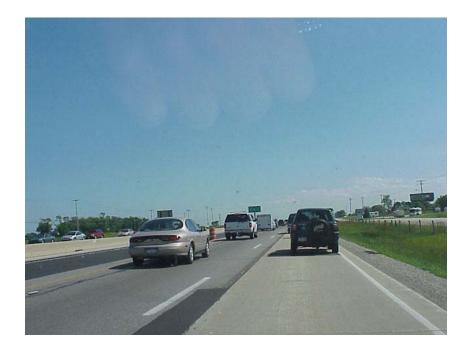
Picture C4. I-94 Southbound Racine County. Construction Phase One. Narrow Gravel Right Shoulder Visible

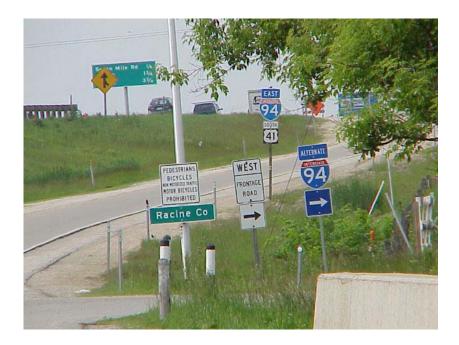
Picture C5. I-94 Southbound Alternate Route Milwaukee-Racine County Border. Detail of connection between 27th Street and West Frontage Road

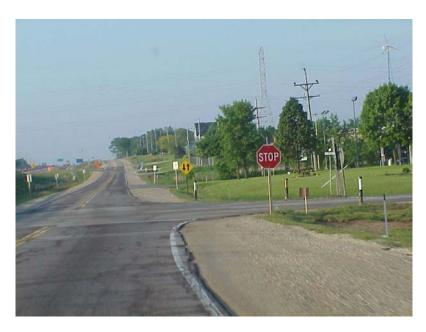
Picture C6. I-94 Southbound Alternate Route. Typical Cross-Section of West Frontage Road at 7-mile Road

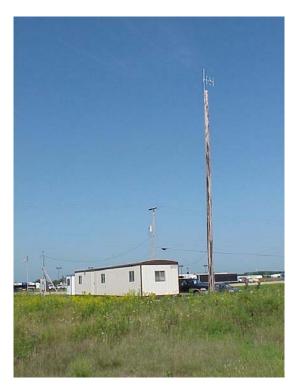
Picture C10. I-94 Southbound, General Mitchell Airport (GMIA) Exit. CMS #1 and Detector A Visible North of the GMIA Overpass

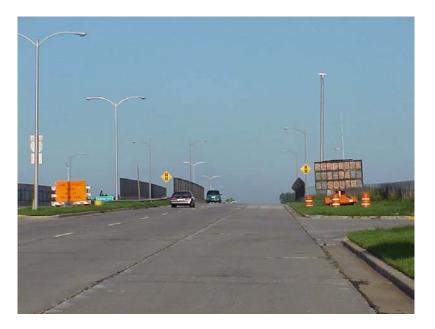
Picture C12. I-94 Southbound, South of Puetz Road, North of Ryan Road CMS #3 and Detector C Visible

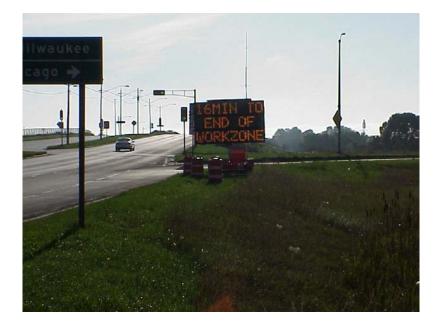
Picture C13. CMS #4 Ryan Road Facing Eastbound Traffic

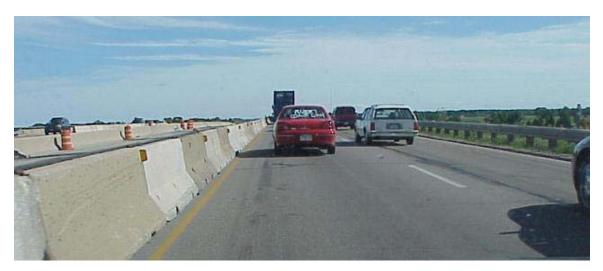
Picture C14. Narrow Left Shoulder on Overpass

During travel time runs it was noted that heavy vehicles often slowed down in overpasses within the work zone, possibly because temporary Jersey barriers were placed very close to the edge of travel lanes (often less than 3 feet—see Picture C14) at these locations.⁶ This barrier placement was necessary while half of the bridge deck was being replaced. Queues would typically form behind the slower-moving vehicles at STH 11, STH 20 and CTH K. When traffic volumes increased on Sundays, and especially in August, the impact of these queues became significant enough to occasionally induce forced-flow unstable conditions along the entire length of the work zone.

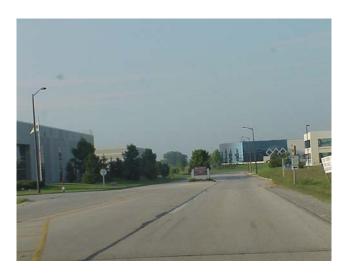
You will need to make a 90 degree turn to the left, to avoid the Grand View Business park at the extension of the frontage road. Notice white rectangular sign pointing to West Frontage Road on the right side of the roadway. Get in the left lane (see picture below). A 90 degree right turn follows shortly, and the frontage road continues south.

Picture: West Frontage Road S of CTH 20, facing south: Grand View Business Park.

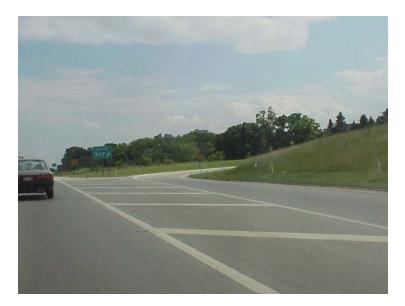
TRAVELING southbound on I-94 **first run of the day: Do not exit here** LAYTON AVENUE (EXIT 317) The exit is AFTER the Layton Ave. bridge. **Not a checkpoint!**

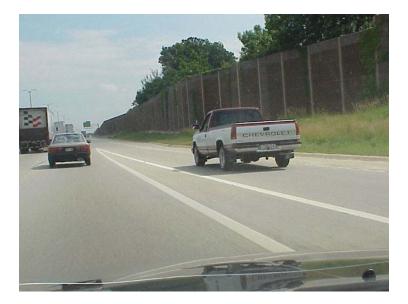
TRAVELING southbound on I-94 **Check point #4 Layton Avenue on-ramp gore** (follows the Layton Avenue exit shown above)

Mark the tip that the two white lines form, seen between the passenger car and the pickup truck.

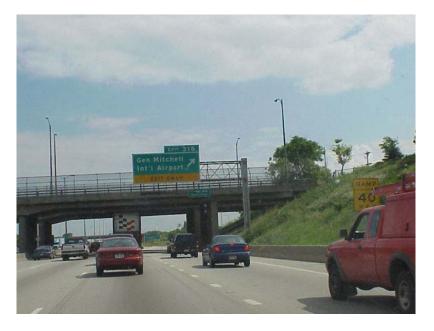
Traveling southbound on I-94. Sign reads: "Exit 315, Gen Mitchell Int'l Airport, Exit Only" Attention: **this is not checkpoint #5**

The proper location for checkpoint #5 is shown in the next picture.

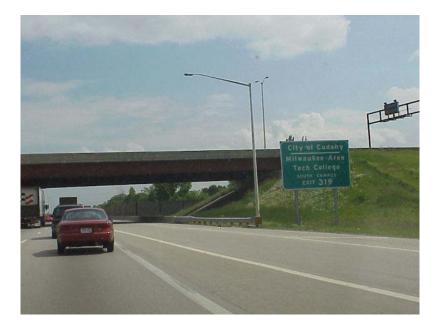
I-94 southbound: checkpoint #5: the sign reads:

"City of Cudahy, Milwaukee Area Tech College, South Campus, Exit 319" There is no sign on the bridge itself. **Bridge beams are red-brown color.**

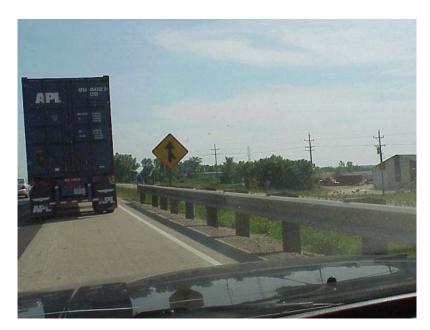
I-94 southbound: checkpoint #12: After Oakwood, you have entered a gentle curve to the right, and now you are exiting a gentle curve to the left. You are already in the construction zone, and you went over a bridge that is being reconstructed. Leaving the bridge, you will see the yellow merge sign behind the guardrail—this is the merge with 27th Street southbound traffic.

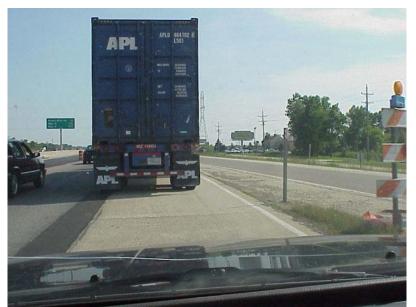
I-94 southbound: checkpoint #12: A little past the yellow diamond merge sign you will see the on-ramp. Mark the tip where the two white lines meet. This is an important point for the study.
