**Evaluation of Ramp Meter Effectiveness for
Wisconsin Freeways, A Milwaukee Case Study:
Part 2, Ramp Metering Effect on Traffic
Operations and Crashes**

Project identification number 0092-45-17

Final Report

Alex Drakopoulos
Mery Patrabanish
Georgia Vergou
Marquette University, Milwaukee

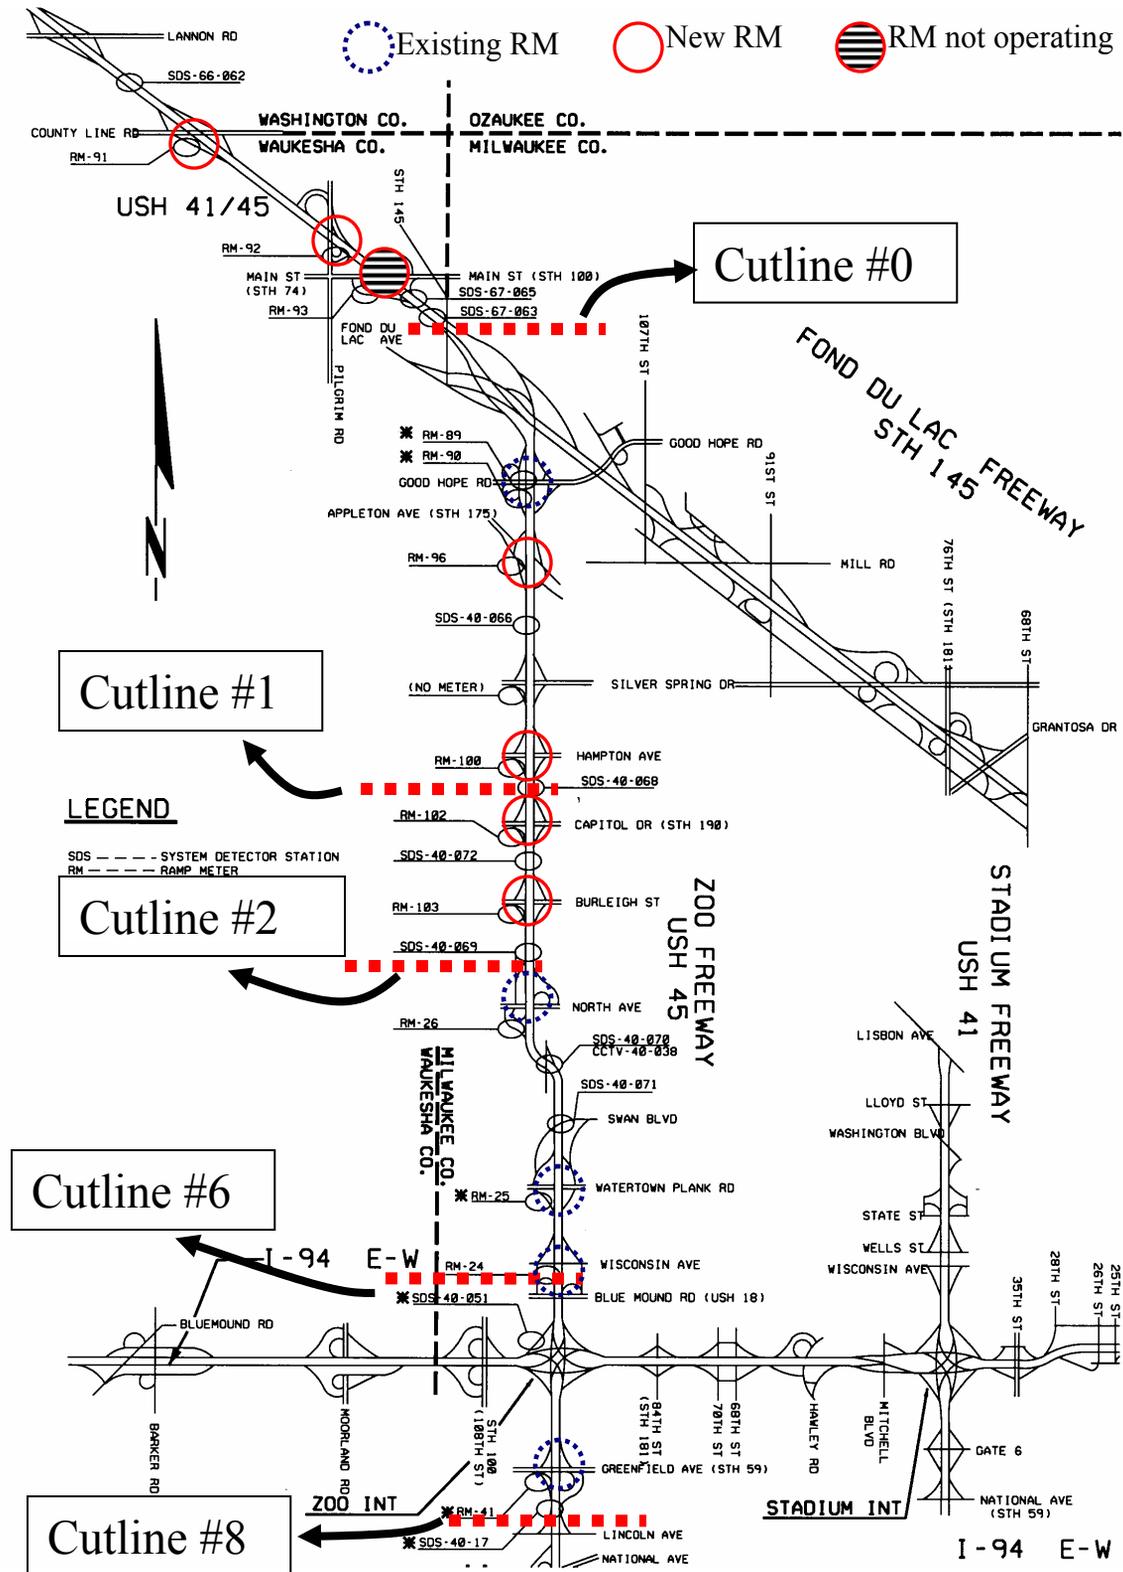
Figure 5-1. Cutlines Used for Traffic Operations MOE Evaluation & Ramp Meter Locations

The analysis corridor consisted of the southbound U.S. 45 direction, starting at the Washington/Waukesha County line on the North, crossing into Milwaukee County and extending through the interchange with I-94 (Zoo interchange) and continuing on to I-894 (the extension of U.S. 45) to a point just South of the Greenfield Avenue on-ramp (**Figure 5-1**).

² These cutline numbers are shown in **Figure 5-1**, and **Table 2-5** page 32 and **Figure 2-4** page 33 in Part 1 of the present report.

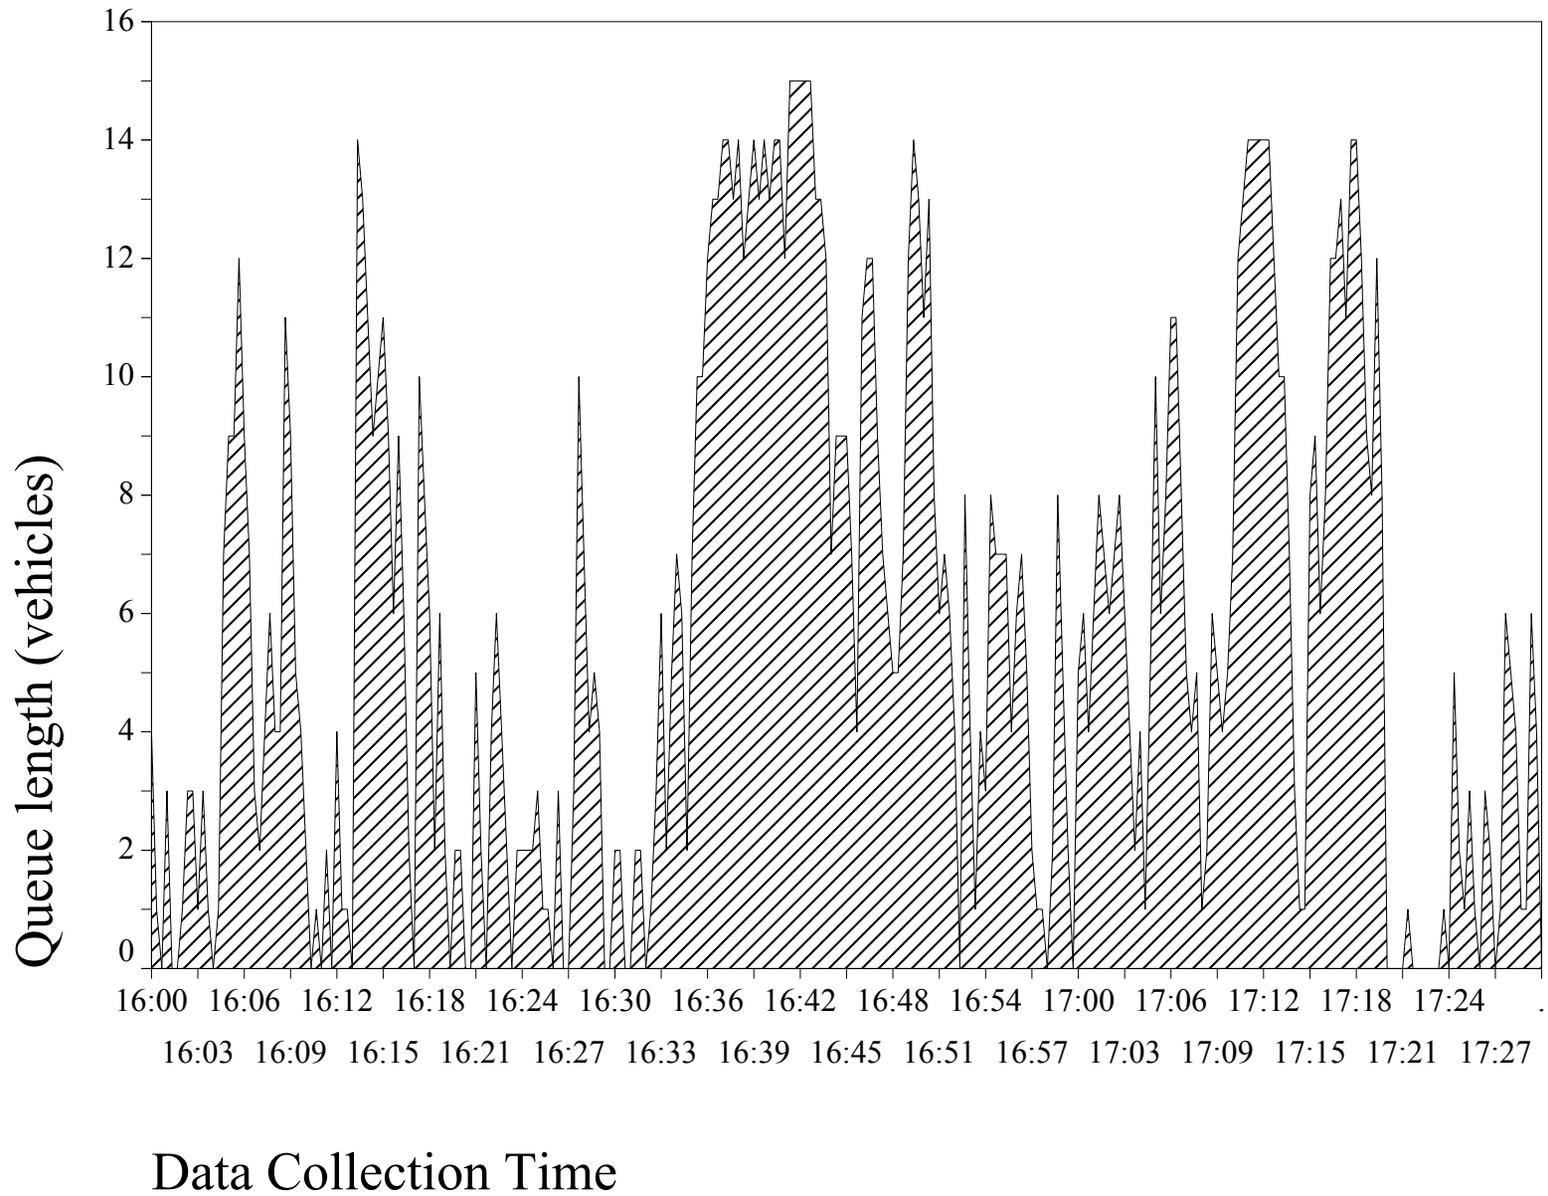
Figure B-1. Ramp Delay & Queue Length Wisconsin Ave. 2/9/2000

The most persistent presence of long queues was observed approximately between 16:35 and 16:45.

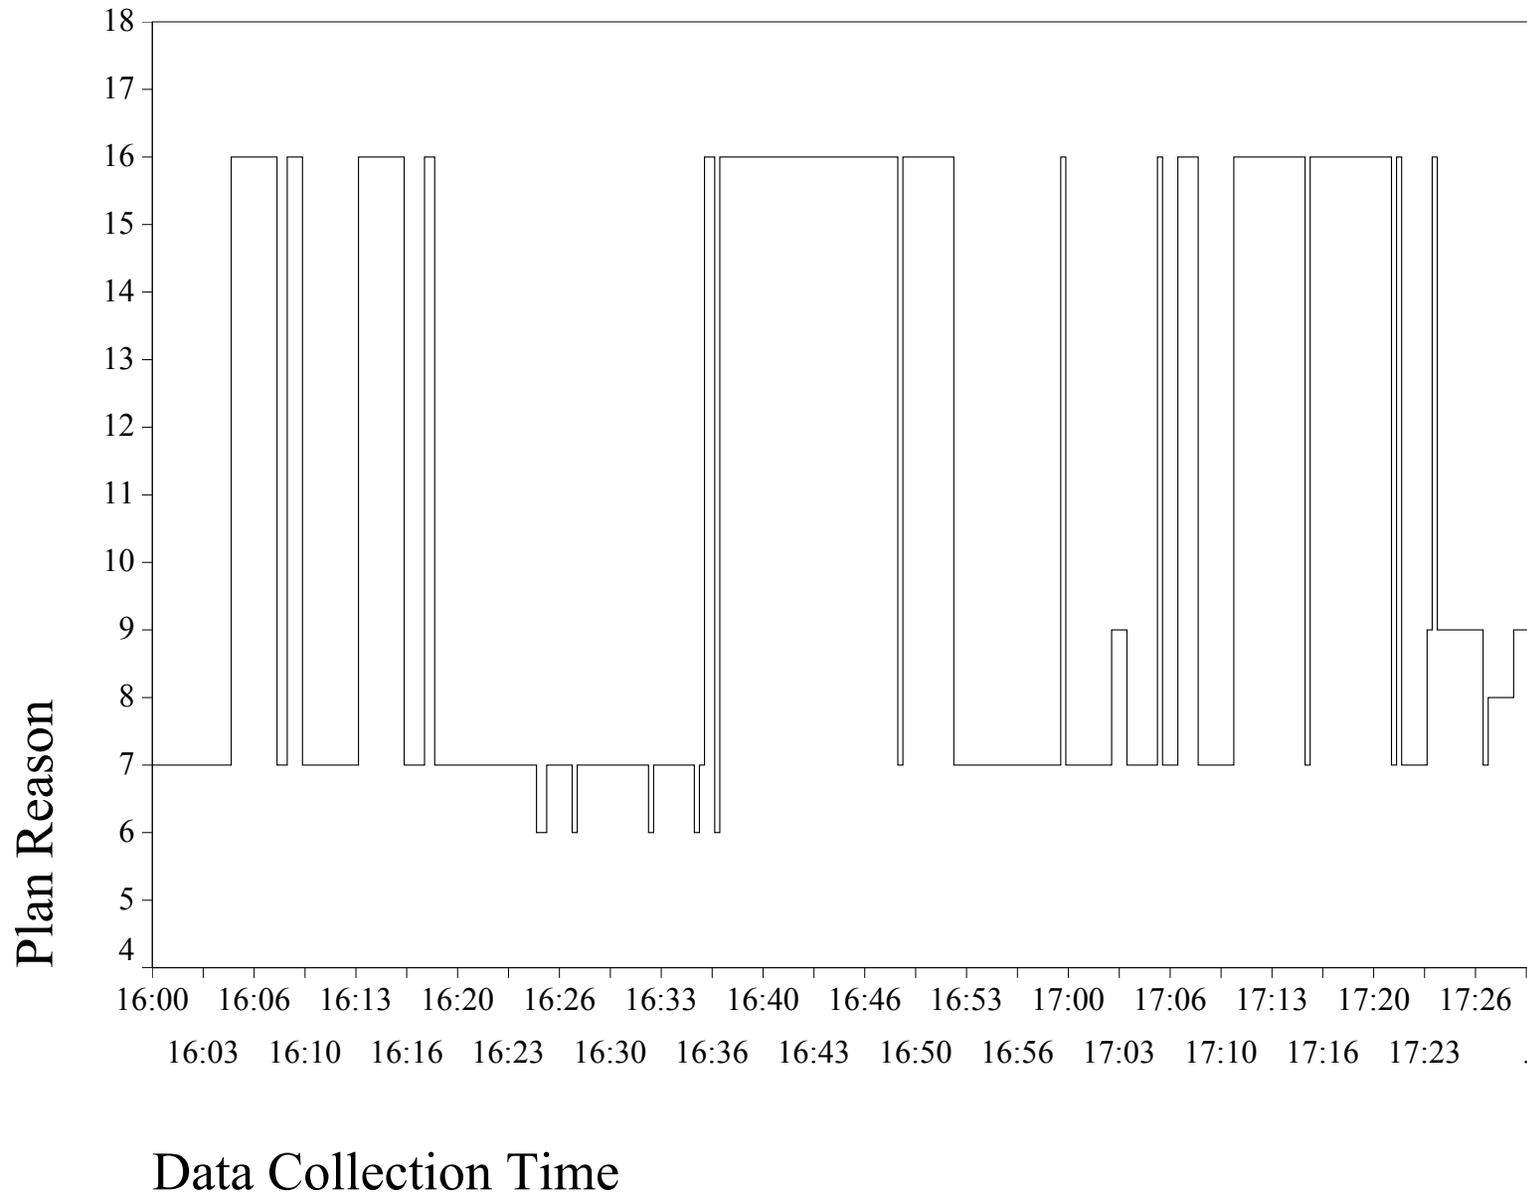
Figure B-2. Reason for Setting Metering Rate

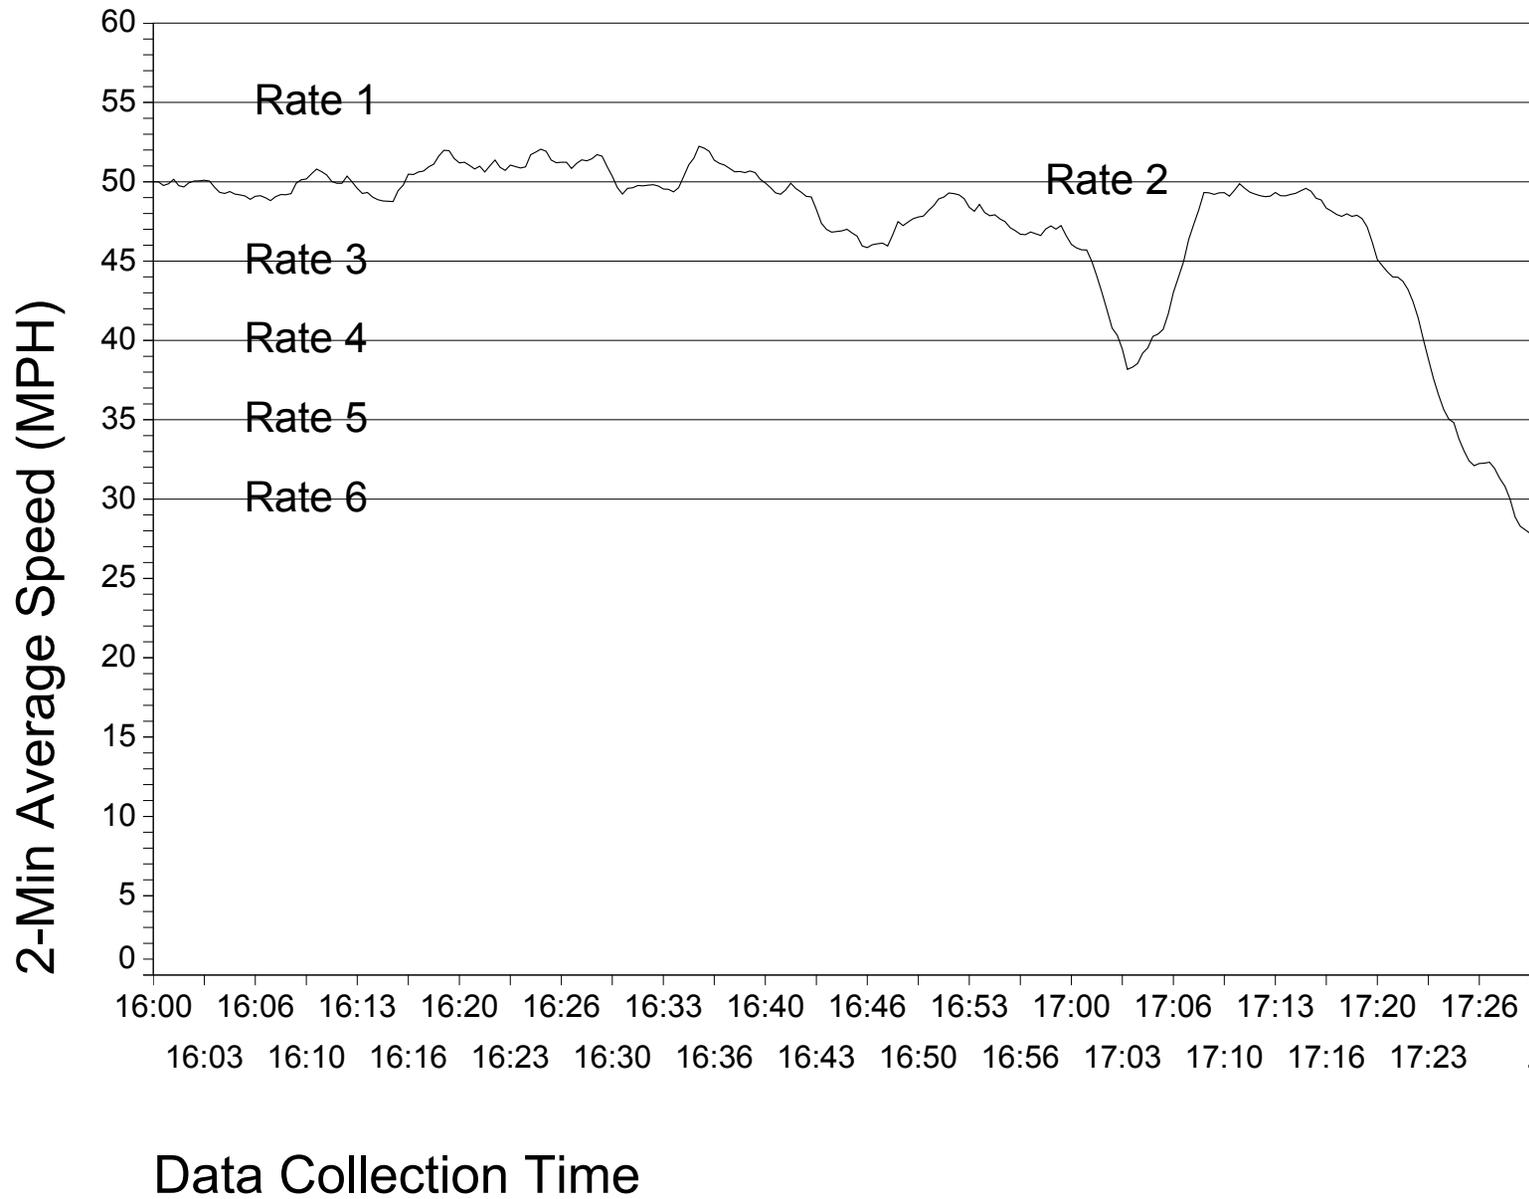
Figure B-3. Mainline Speed.

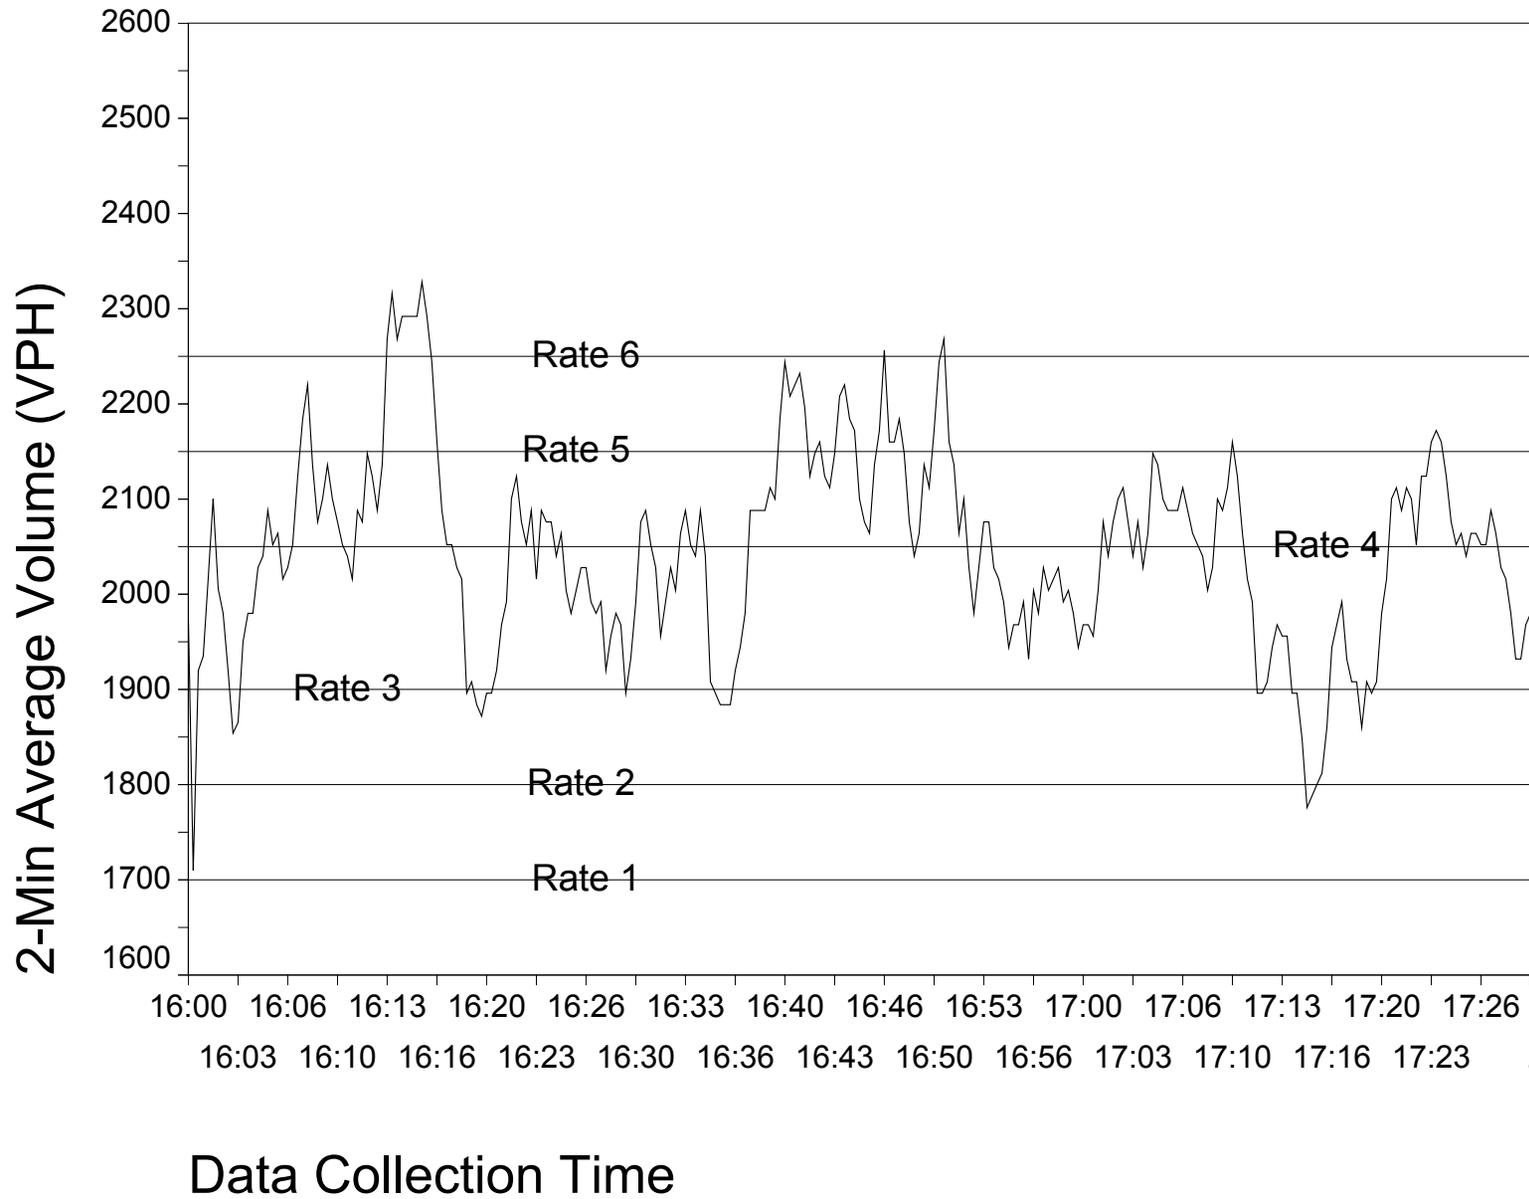
Figure B-4. Mainline Lane Volume.

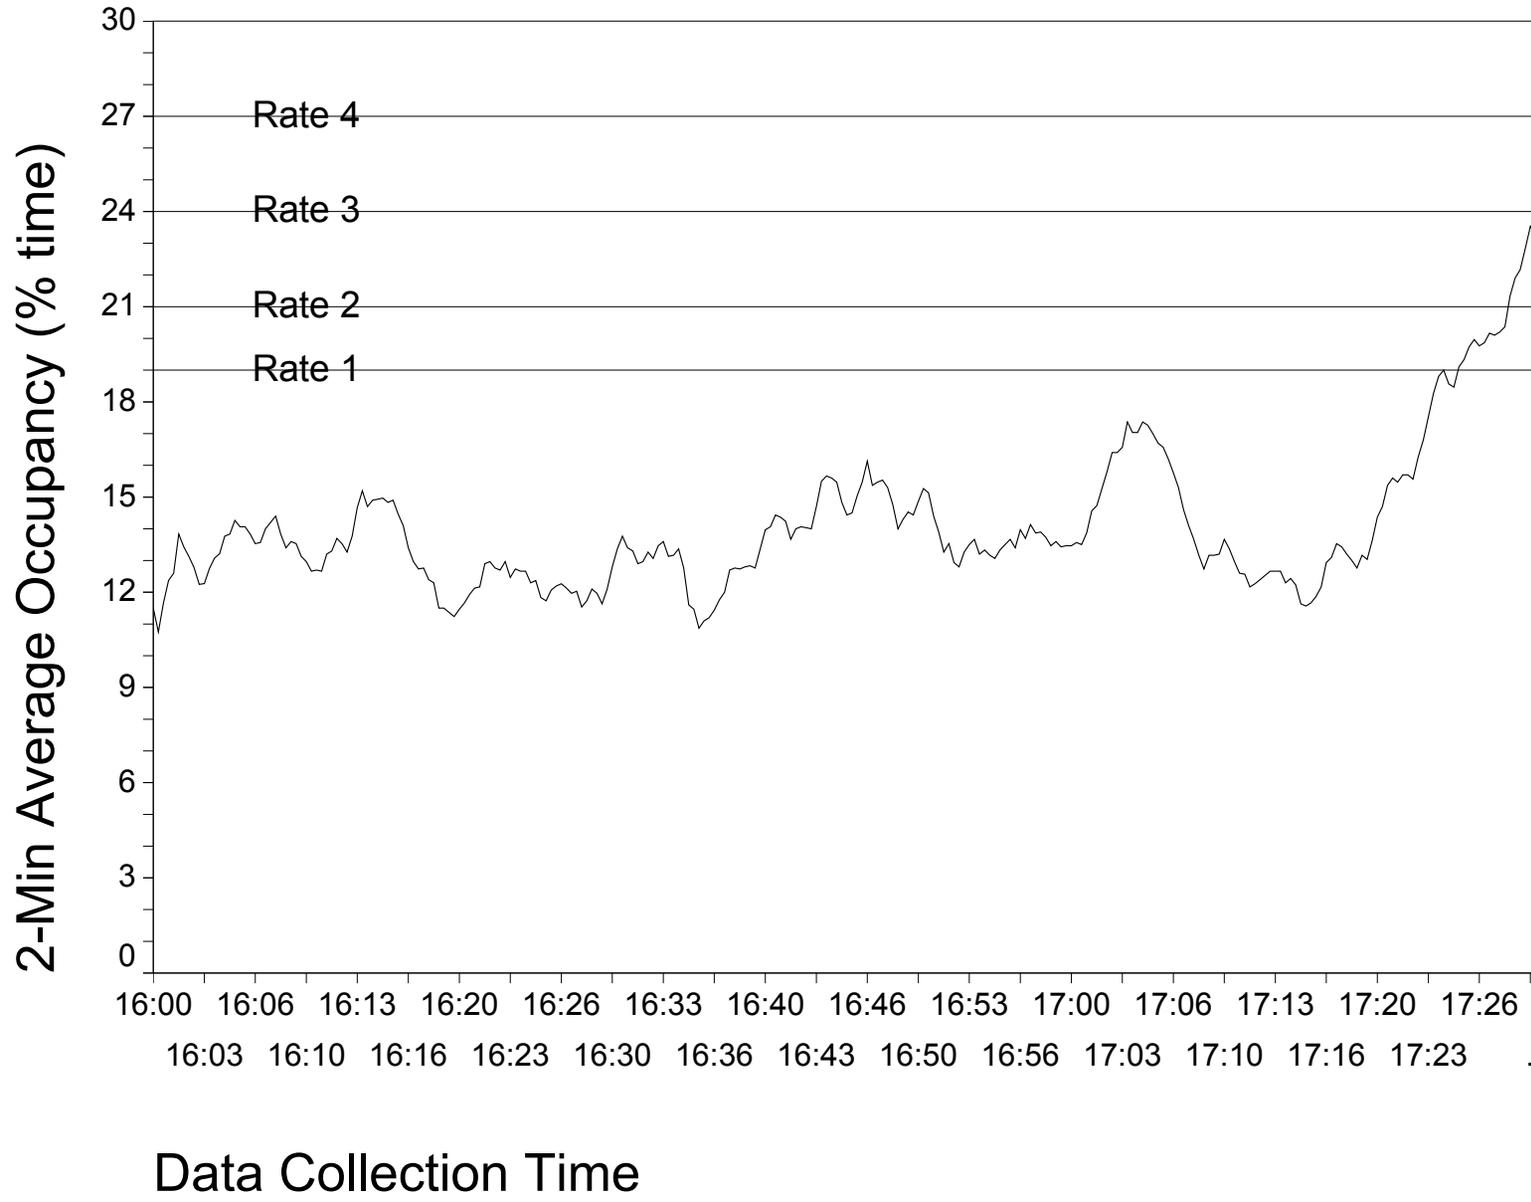
Figure B-5. Mainline Lane Occupancy.

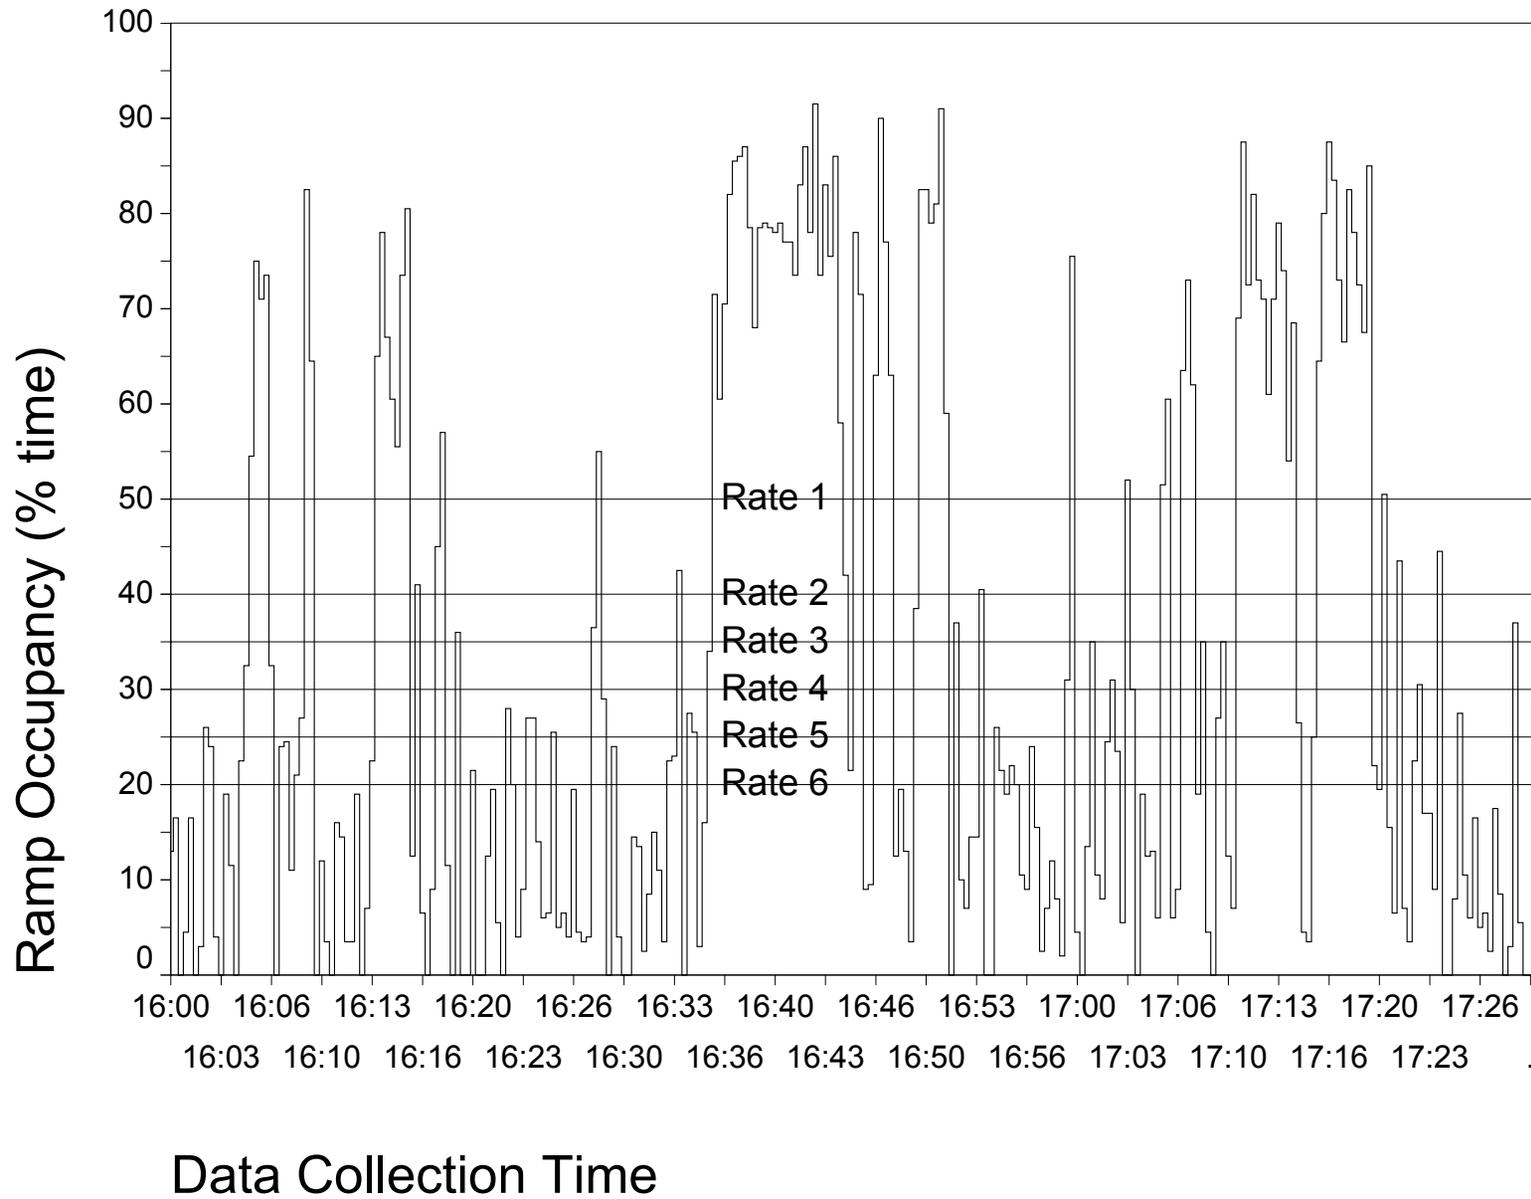
Figure B-6. Ramp Occupancy.

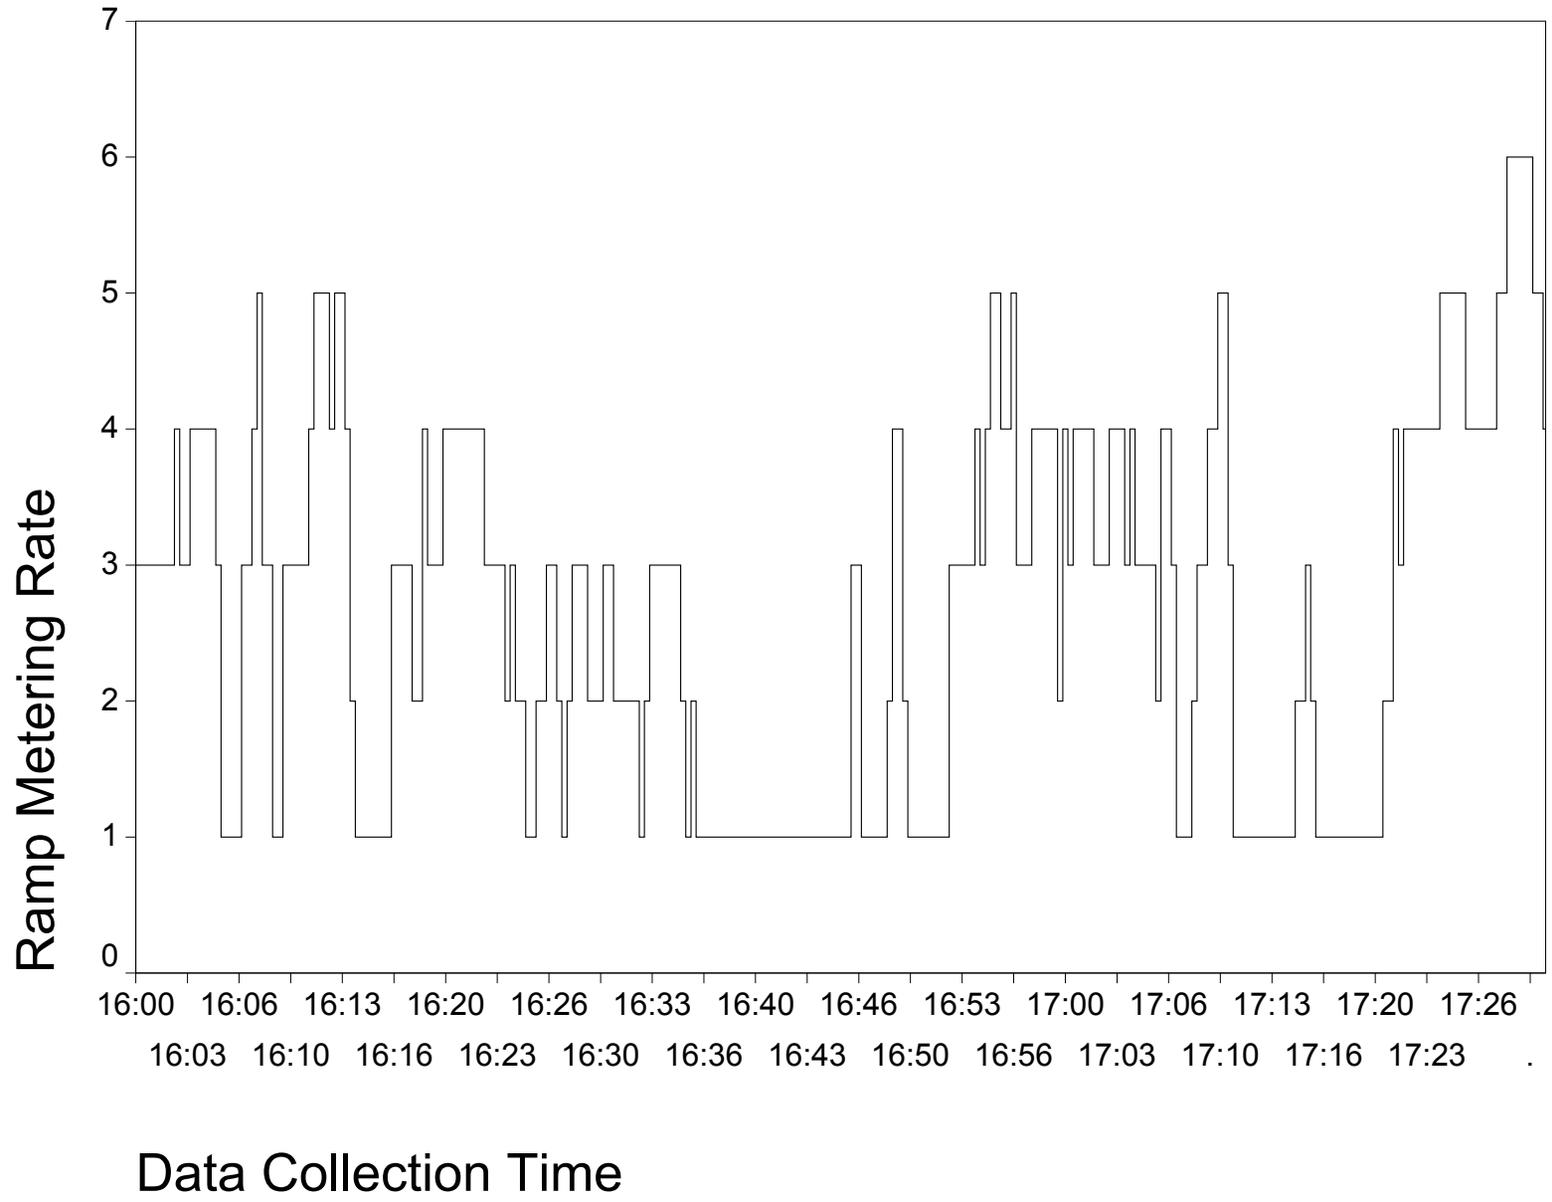
Figure B-7. Chosen Metering Rate.

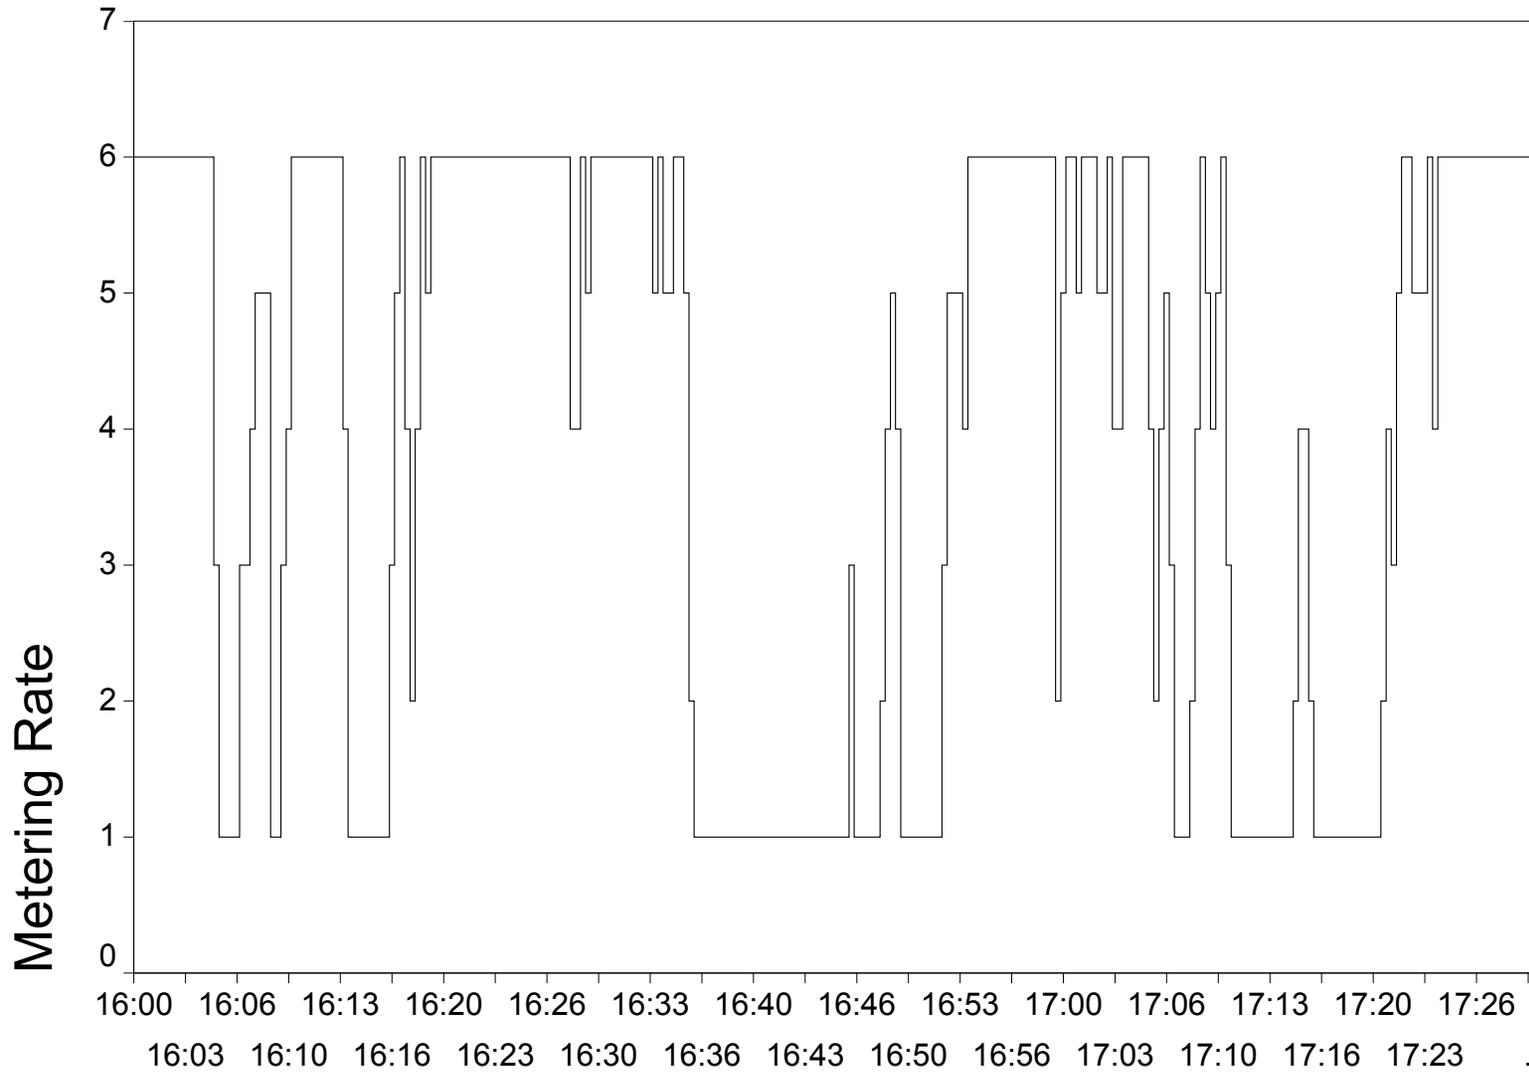
Figure B-8. Metering Rates Based on Ramp Occupancy.

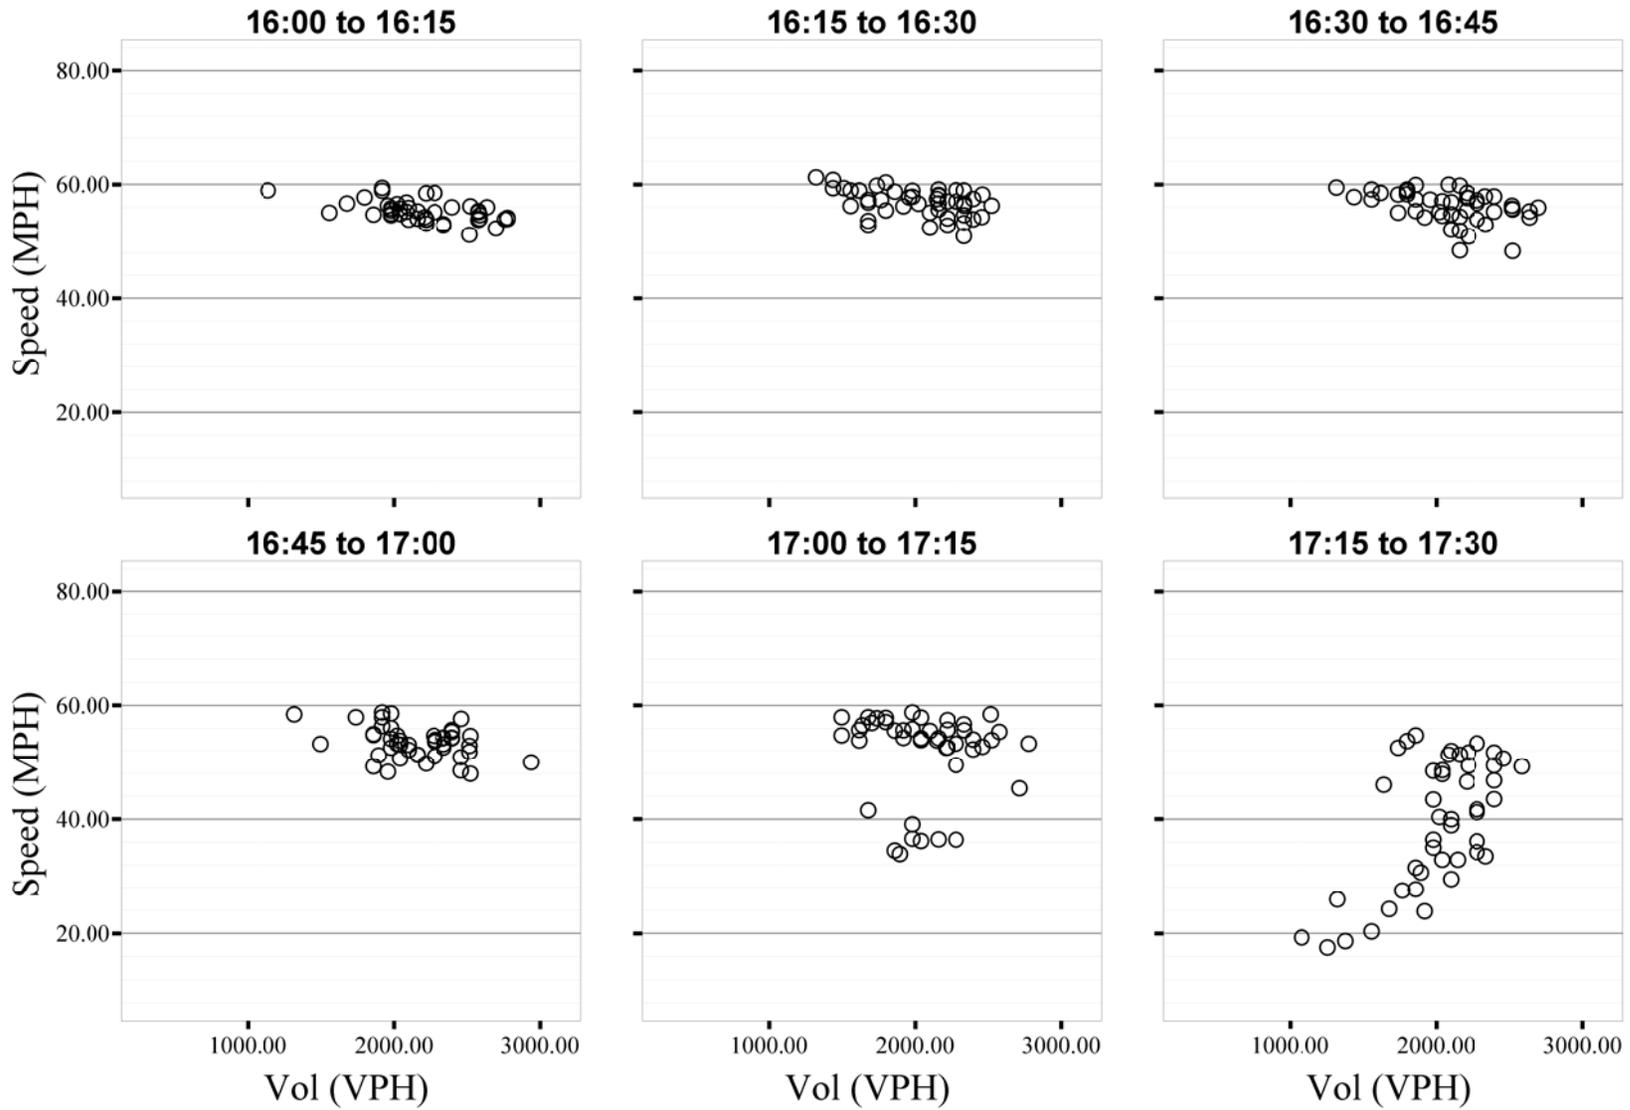
Figure B-9. Mainline Speed-Volume Feb 9, 2000.

Speed-volume and speed-occupancy graphs (**Figures B-9** and **B-10**) are provided for each quarter hour during this peak period. Similar graphs (**Figures B-11** and **B-12**) are provided for prevailing weekday afternoon peak conditions at this location based on information collected at the same location during all data collection days: February 1, 2, and 3 (week 1), February 8, 9, and 10 (week 2) March 14, 15, and 16 (week 3), and March 21, 22, and 23 (week 4).

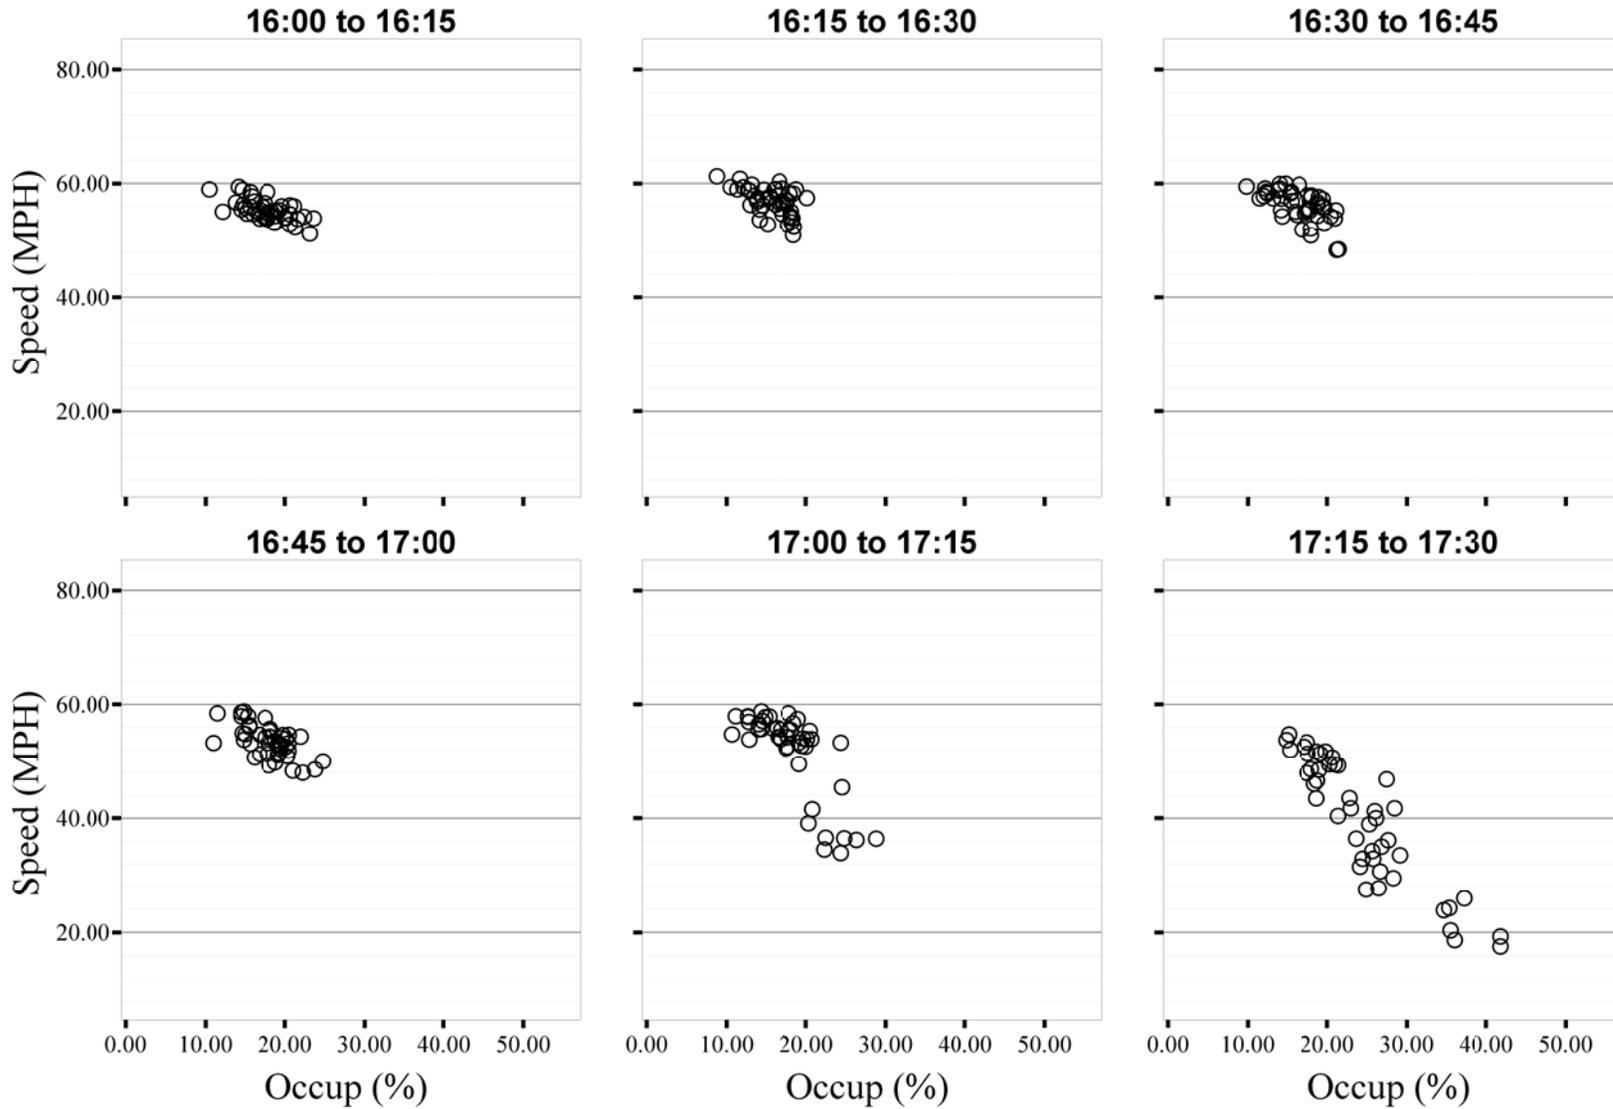
Figure B-10. Mainline Speed-Volume Feb 9, 2000.

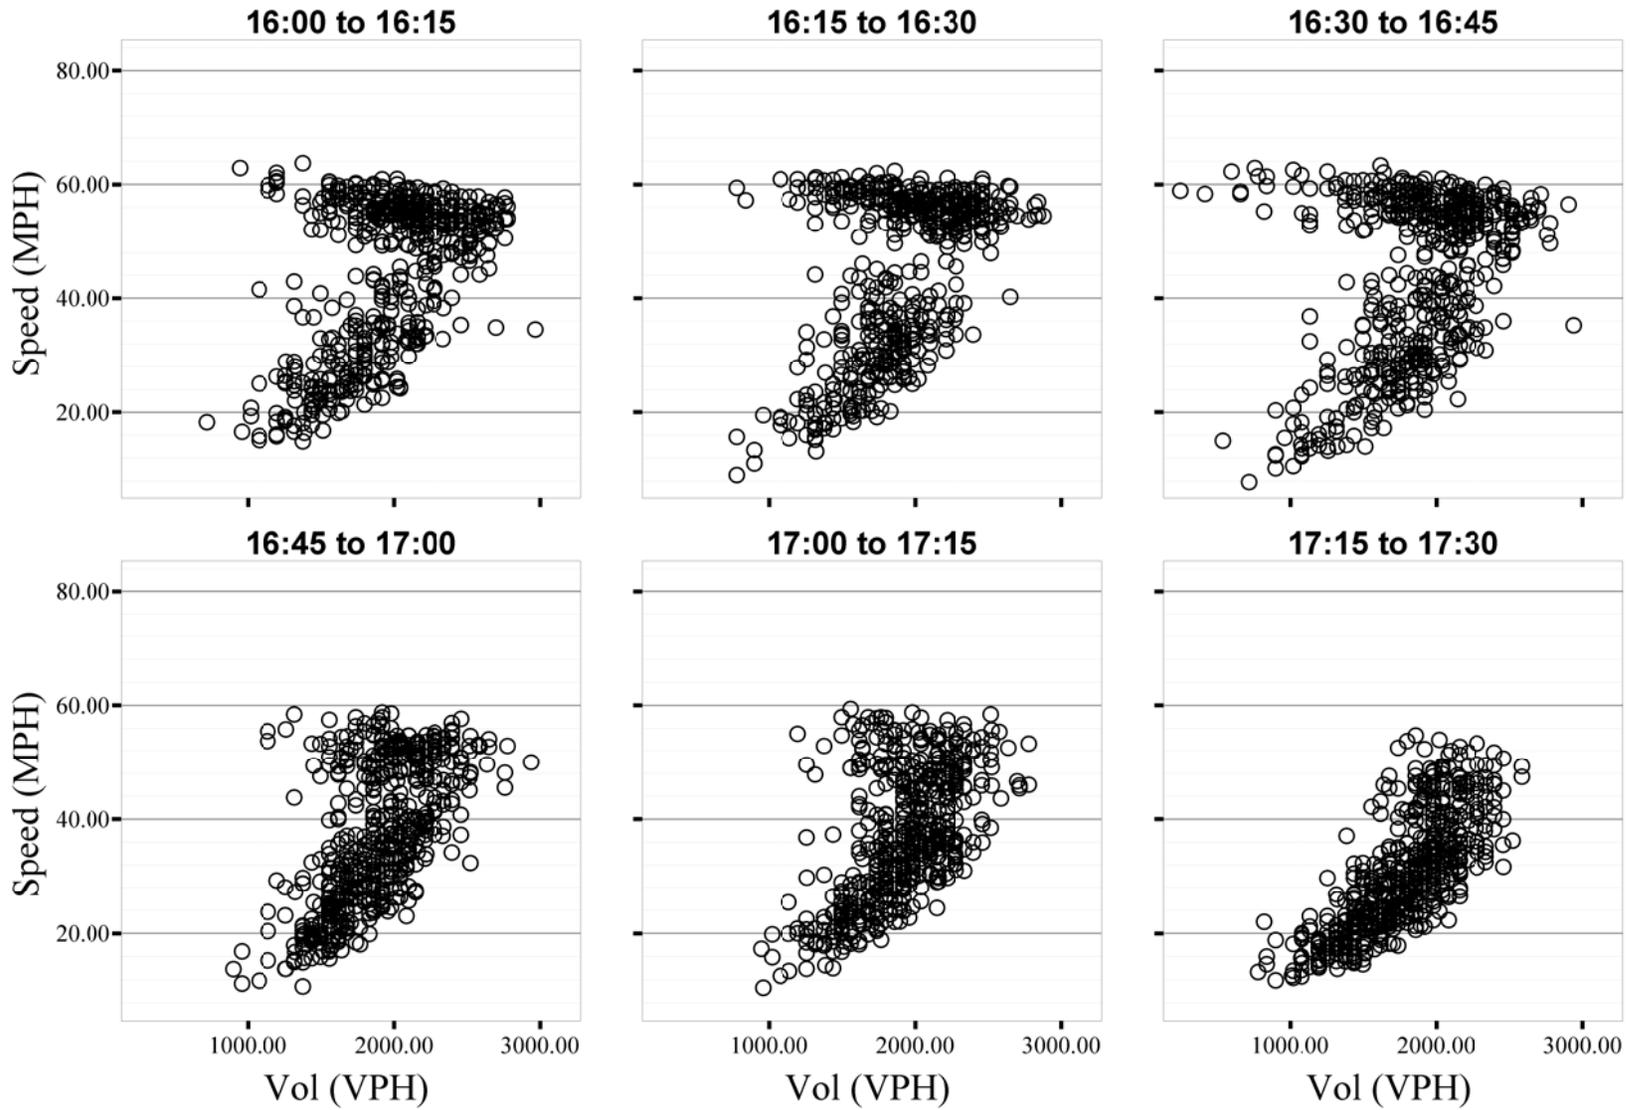
Figure B-11. Mainline Speed-Volume All Days.

Figures B-11 through B-16 present similar information at the same location, based on the 12 afternoon peak periods of the study data collection days. This information is intended to provide a background of traffic conditions at the analyzed location, for comparisons with the afternoon peak period of February 9, 2000, and fine-tuning ramp metering parameters.
