**Evaluation of Ramp Meter Effectiveness for
Wisconsin Freeways, A Milwaukee Case Study:
Part 2, Ramp Metering Effect on Traffic
Operations and Crashes**

Project identification number 0092-45-17

Final Report

Alex Drakopoulos
Mery Patrabanish
Georgia Vergou
Marquette University, Milwaukee

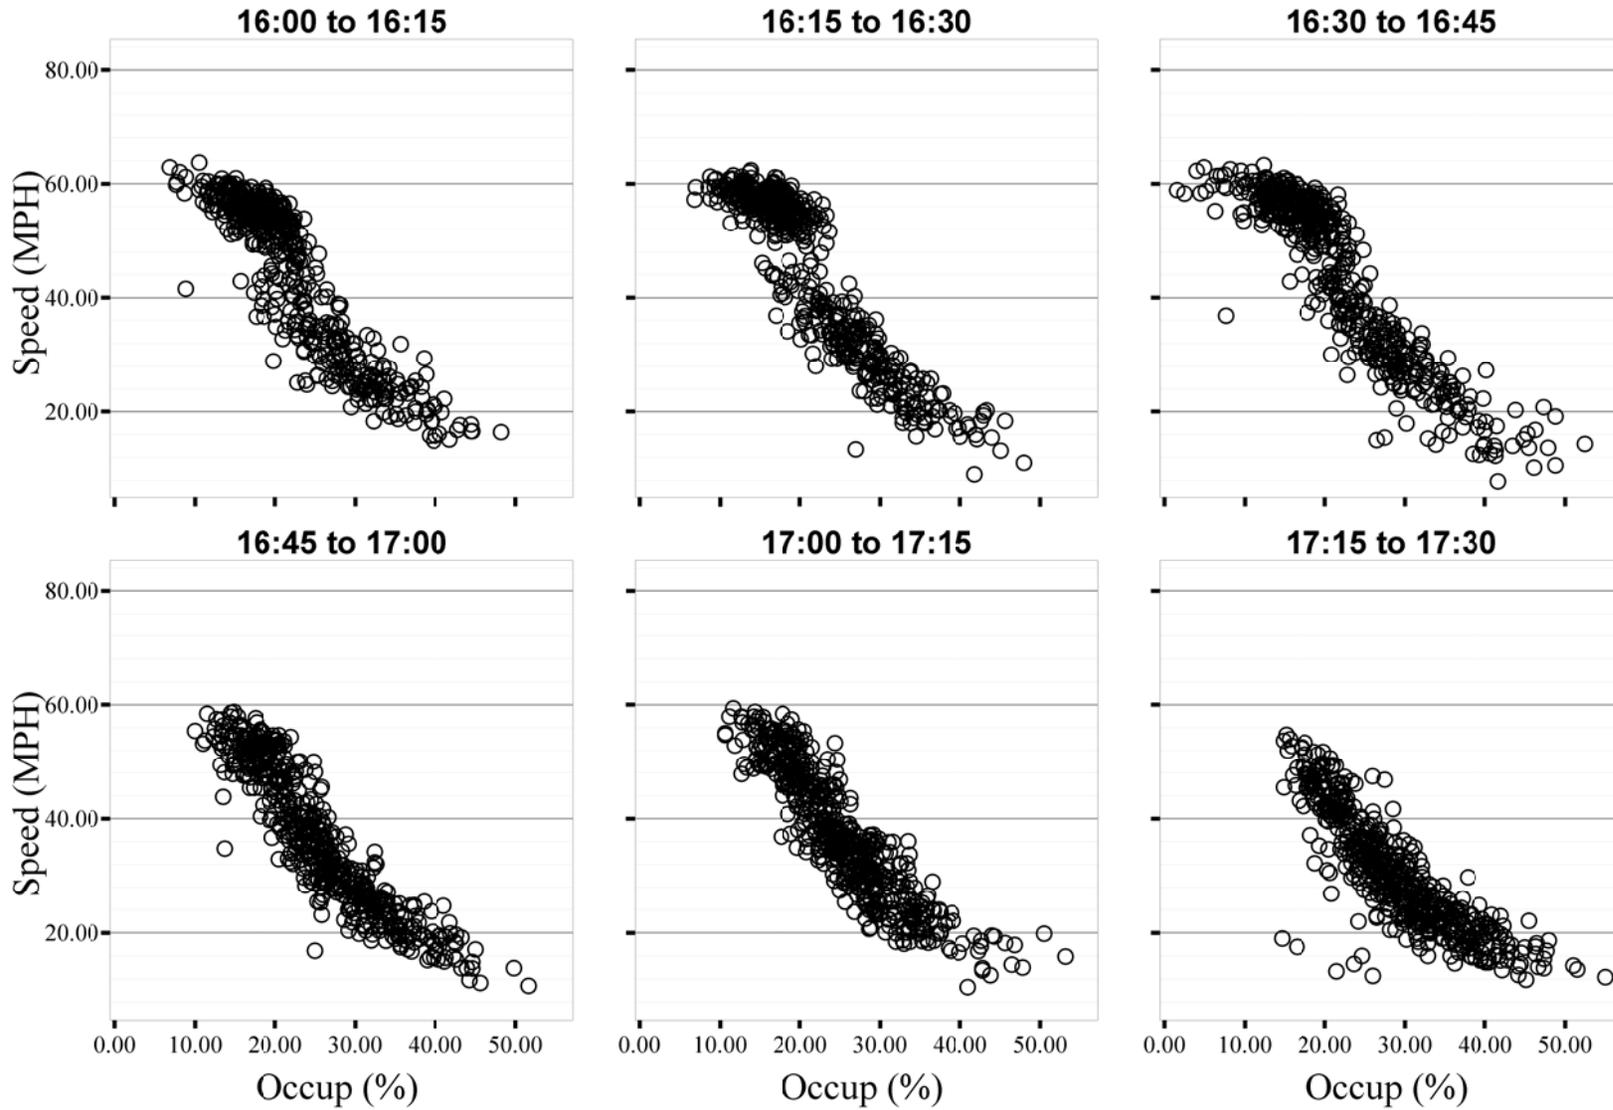
Figure B-12. Mainline Speed-Volume All Days.

Speed-volume and speed-occupancy graphs (**Figures B-9** and **B-10**) are provided for each quarter hour during this peak period. Similar graphs (**Figures B-11** and **B-12**) are provided for prevailing weekday afternoon peak conditions at this location based on information collected at the same location during all data collection days: February 1, 2, and 3 (week 1), February 8, 9, and 10 (week 2) March 14, 15, and 16 (week 3), and March 21, 22, and 23 (week 4).

Figures B-11 through B-16 present similar information at the same location, based on the 12 afternoon peak periods of the study data collection days. This information is intended to provide a background of traffic conditions at the analyzed location, for comparisons with the afternoon peak period of February 9, 2000, and fine-tuning ramp metering parameters.

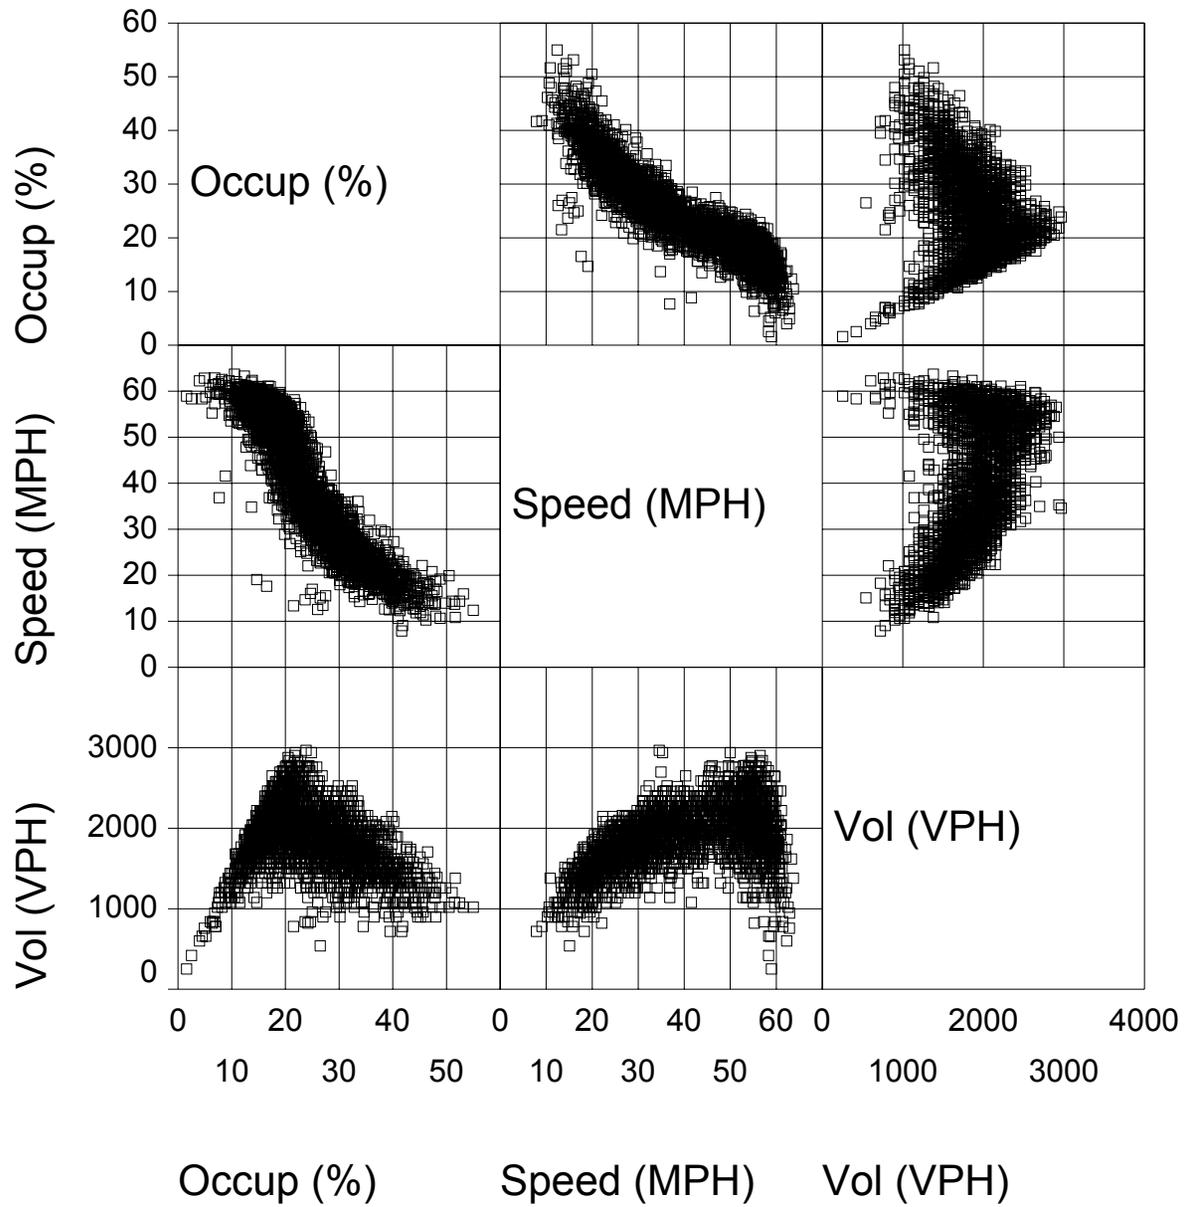
Figure B-13. Mainline Occupancy, Speed and Volume

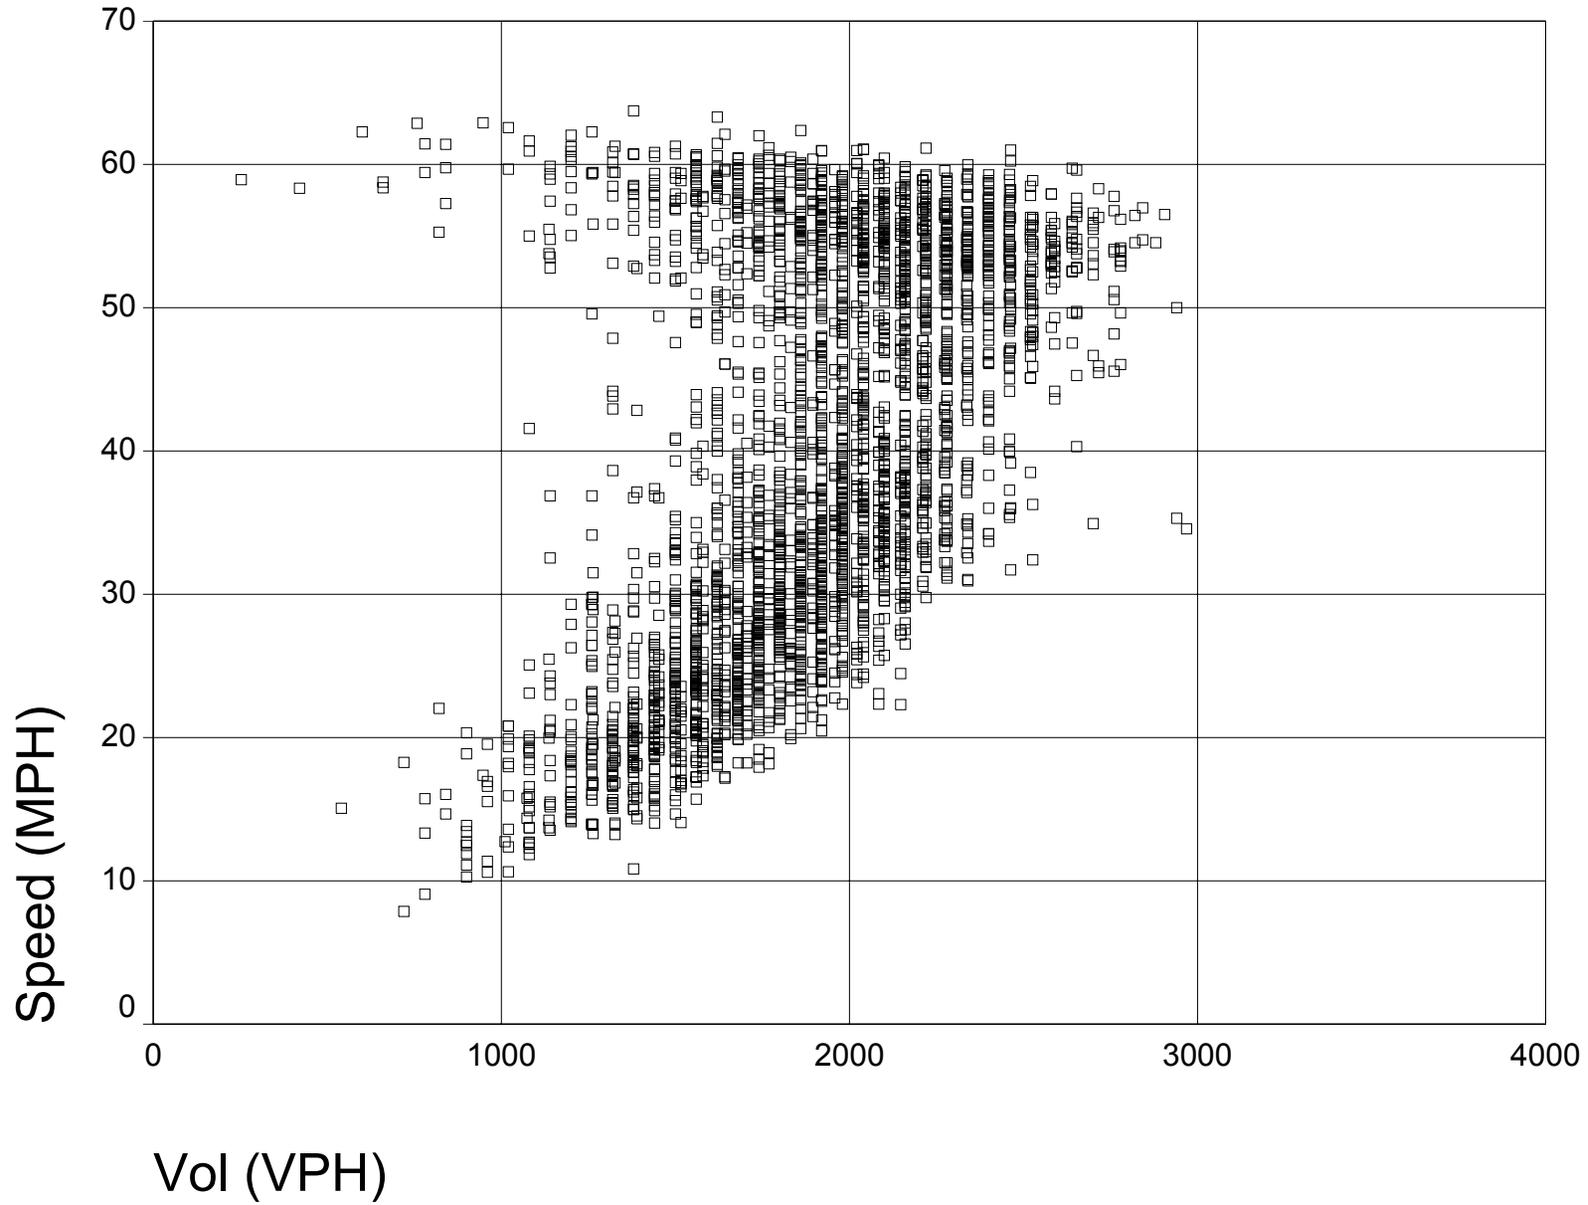
Figure B-14. Mainline Speed and Volume.

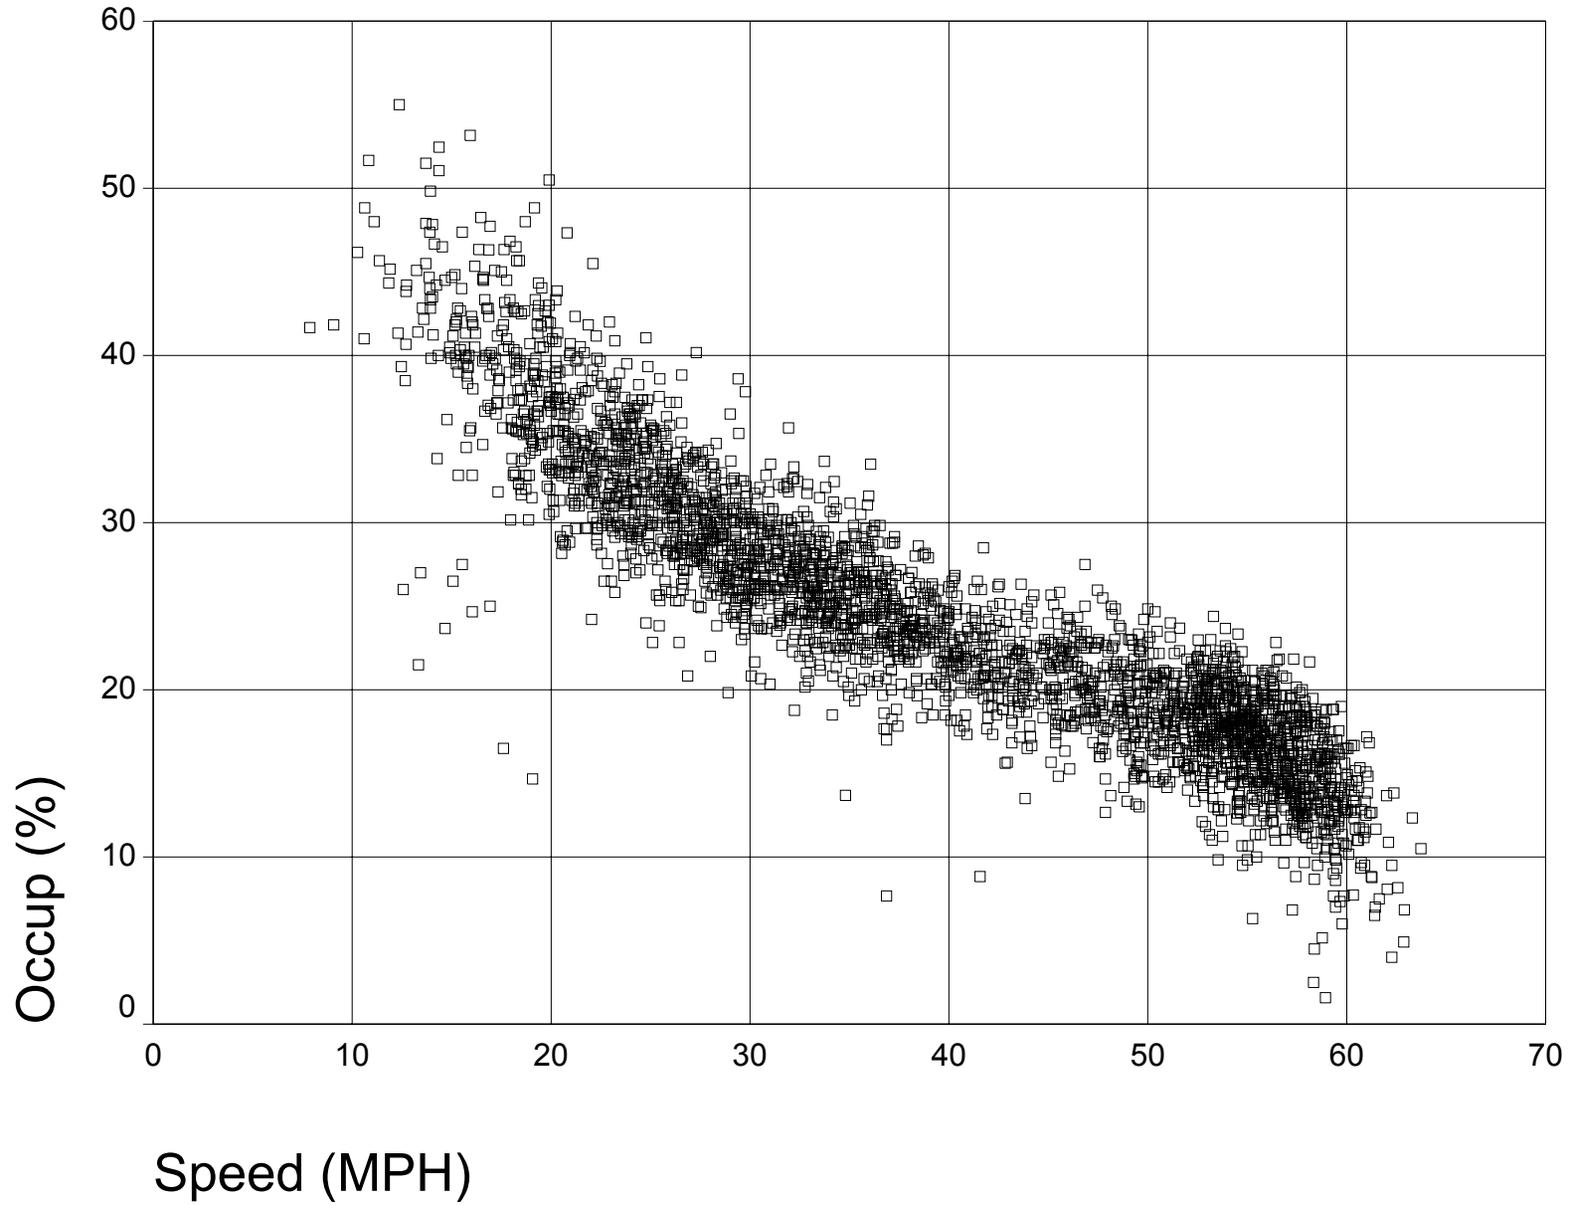
Figure B-15. Mainline Occupancy and Speed.

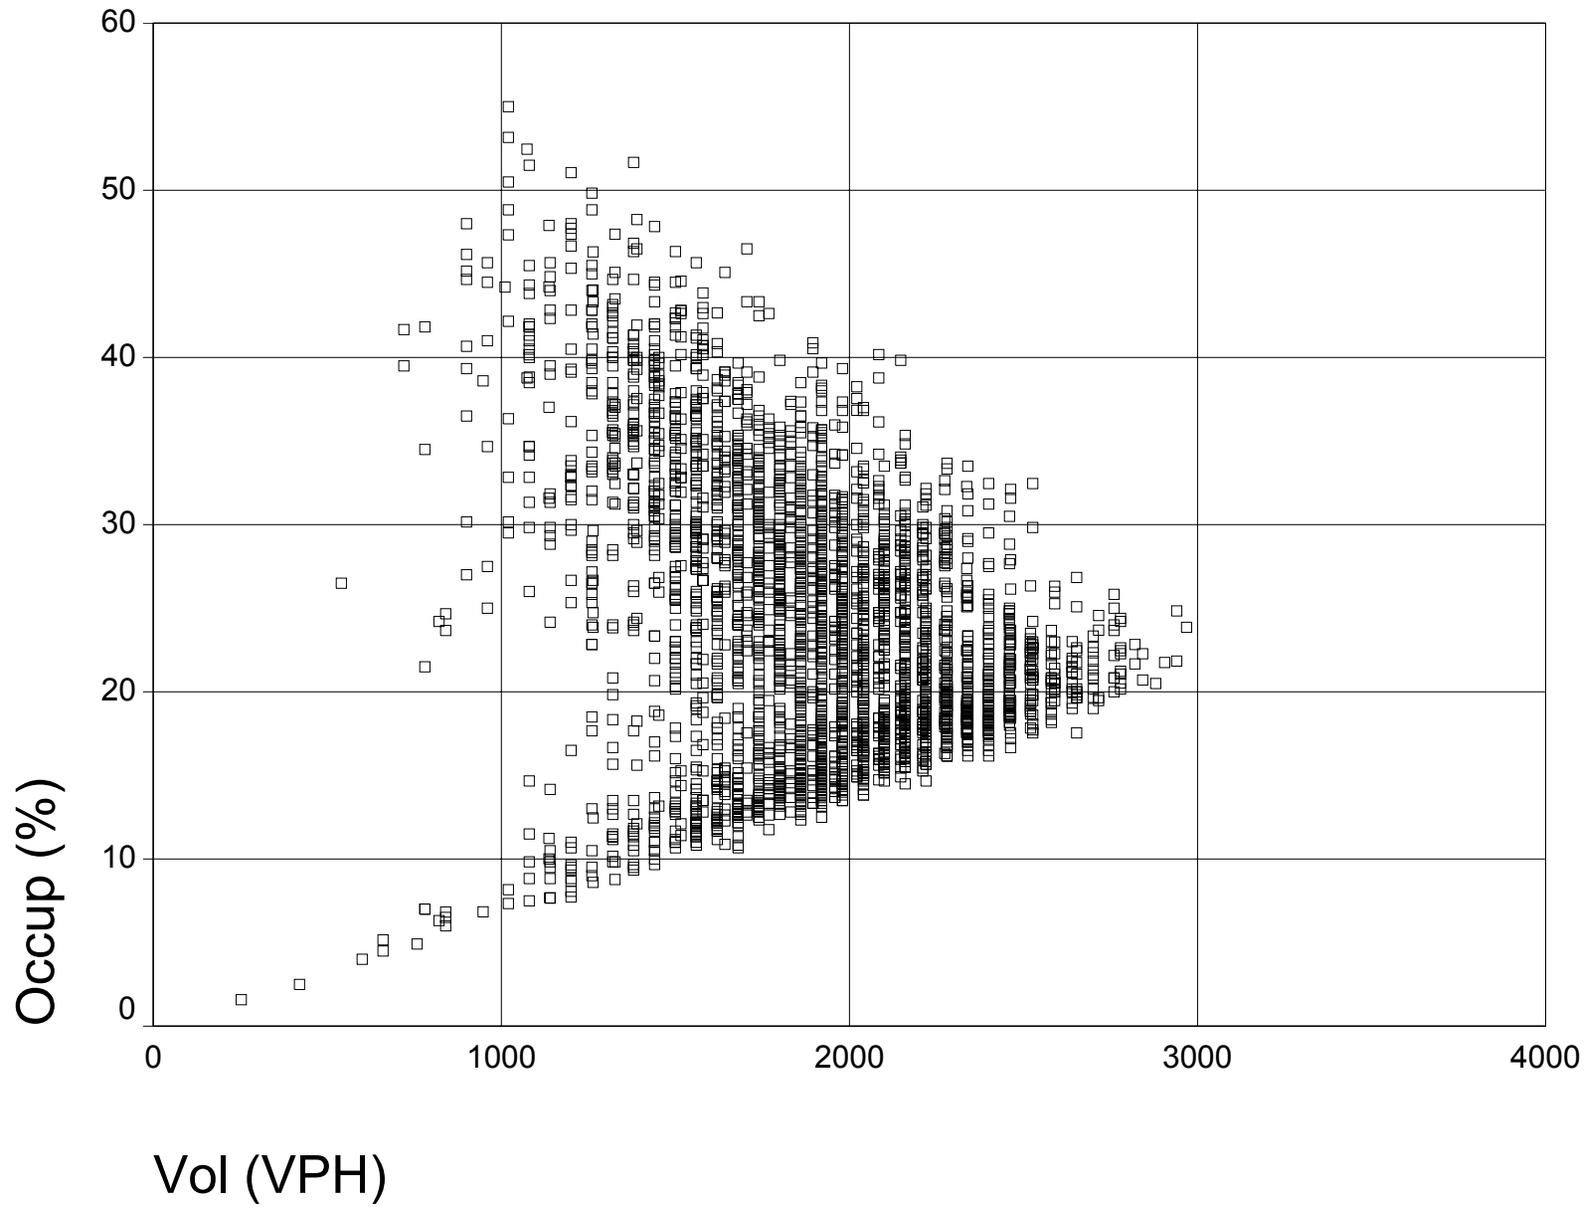
Figure B-16. Mainline Occupancy and Volume.
